Lakeview Amphitheater

Draft Environmental
Impact Statement

SEQR Lead Agency:
Onondaga County

June 2014

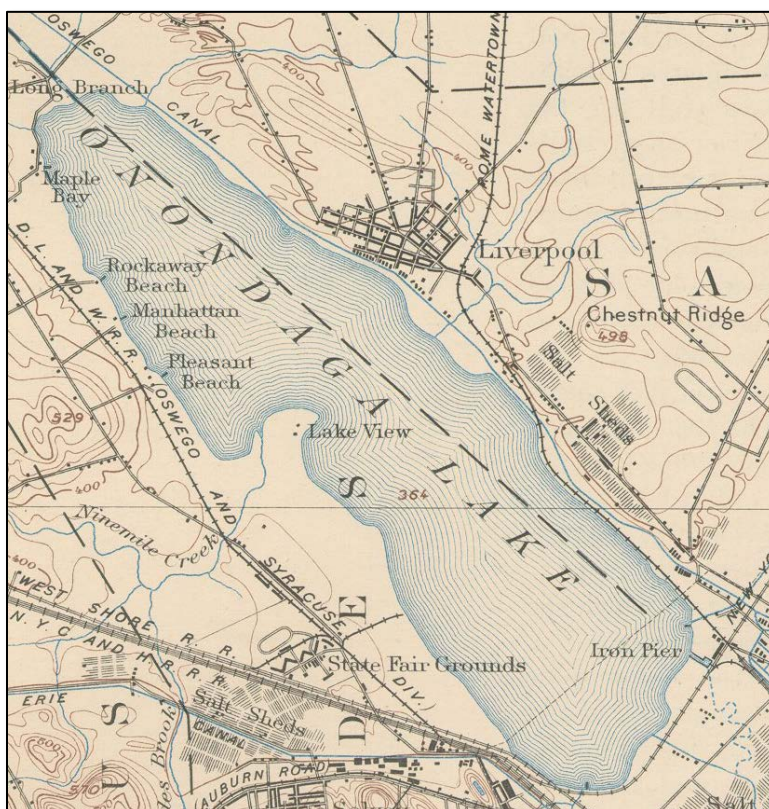
Image ES-1: 1898 United States Geological Survey (USGS) Syracuse Southwest Quadrangle, illustrating the location of the former Lake View Hotel and Rockaway, Manhattan, and Pleasant Beaches.

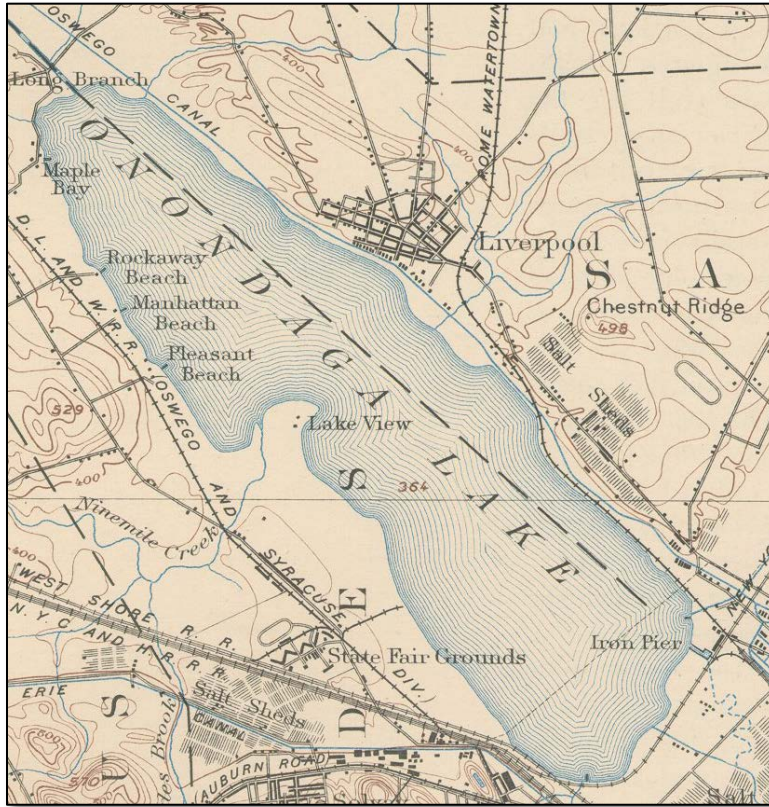
Image 2-2: 1898 United States Geological Survey (USGS) Syracuse Southwest Quadrangle,
illustrating the location of the former Lake View Hotel and Rockaway, Manhattan, and Pleasant Beaches.

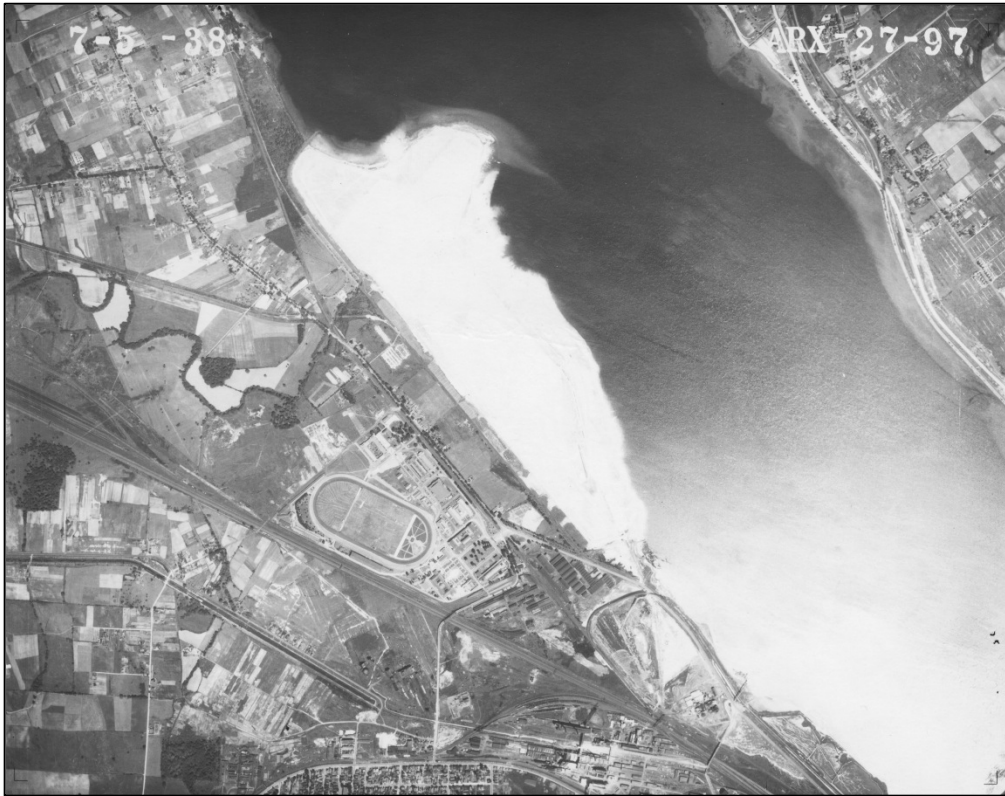
Image 2-3: 1938 aerial photograph illustrating the then-active wastebeds.

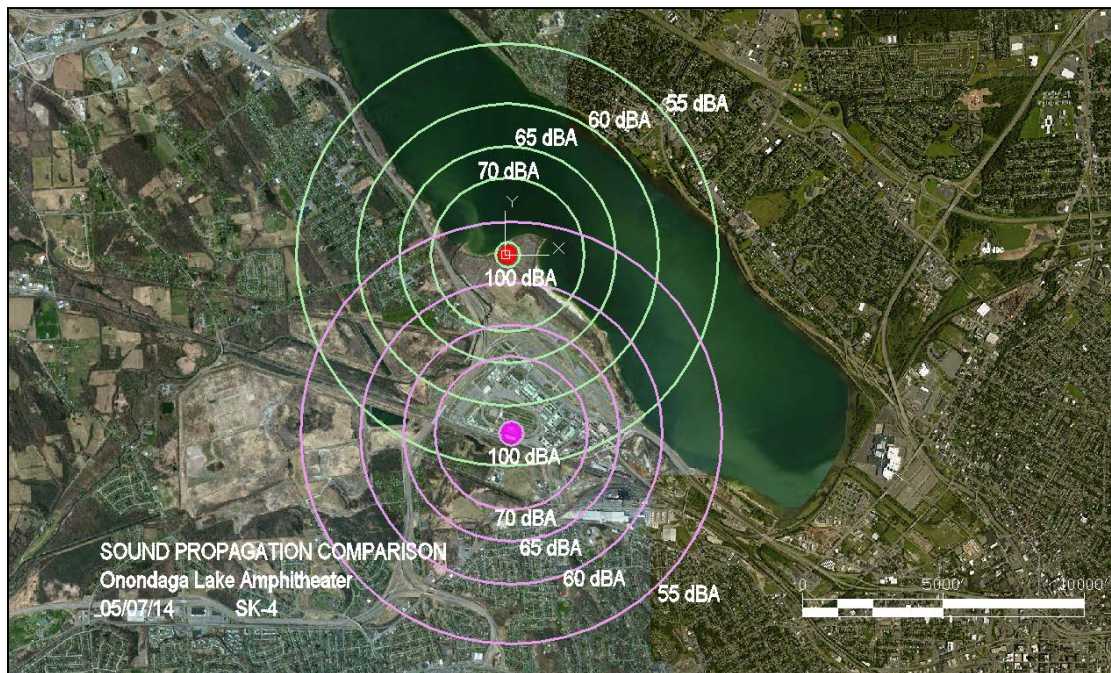
Image 3-9: Sound Propagation Amphitheater and NYS Fairgrounds Grandstand

As can be seen in the model results, there are some residential areas along State Fair Boulevard in Lakeland where maximum sound levels from some events are predicted to exceed 65 dBA. Also, from Image 3-8, it can be seen that these sounds would appear louder than that from a concert at the State Fairgrounds under similar conditions. Using the 65 dBA threshold, some amount of annoyance/impact could be expected in the Lakeland area based on the modeling conducted by Acoustic Dimensions, depending on background conditions. However, as depicted above in Image 3-7, no receptors are predicted to experience sound levels in excess of 70 dBA as a result of the Amphitheater.

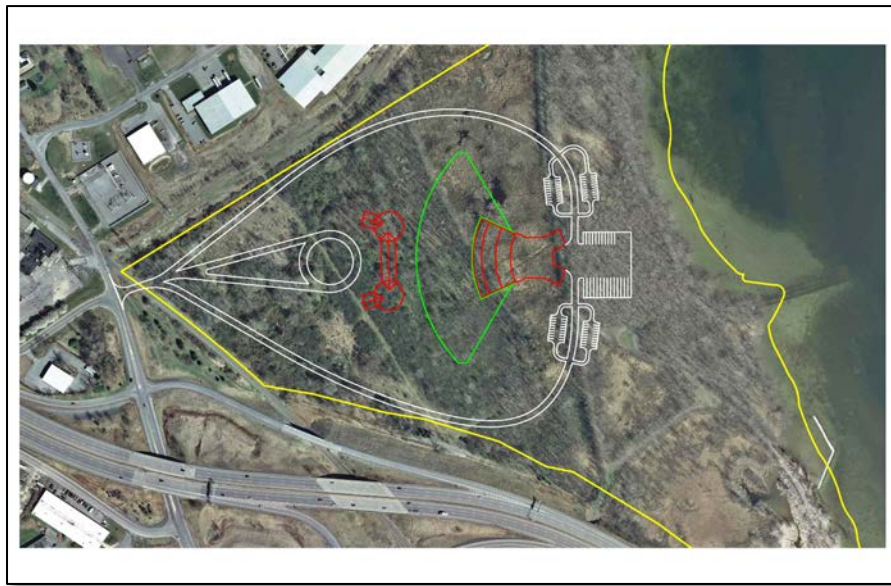
Image 5-3: Maple Bay Site Layout

This site was the only alternate area identified on the western shore that had the minimum space required to accommodate the proposed stage house and seating areas, however there is little additional space for ancillary facilities or amenities. The site is located off of Van Vleck Road at Exit 5 from Interstate 690 adjacent to Dwight Industrial Park. It currently is vacant with the exception of the County West Shore Trail right of way. A proposed site layout for this parcel is shown in Image 5-3.

Siting at the Maple Bay location would require offsite parking and shuttle service to accommodate the planned events. Although alternative parking may be available at Longbranch Park or other County properties, none of these areas provide sufficient space for the expected 6500 vehicles associated with a major event. Under this alternative, construction would most likely take place at several sites concurrently to accommodate offsite parking and reduced scale amenities would be provided at the main venue site. Viability of the venue as a national tour stop may be diminished due to the site constraints and reduced amenities. Public utilities are available nearby and renewable sourced power could be provided at reduced cost from the Village of Solvay Municipal Electric system. Special consideration would have to be given to geotechnical conditions on this site, however these may be less severe than at the Lakeview site. Operating costs would be greater as most parking would remain offsite requiring use of shuttles. Currently, a large portion of the Maple Bay site is located within a documented wetlands area. Siting at this location would require a major wetlands offset mitigation effort to accommodate the necessary site work resulting in additional project cost and a lengthened implementation schedule. By contrast, there would be little

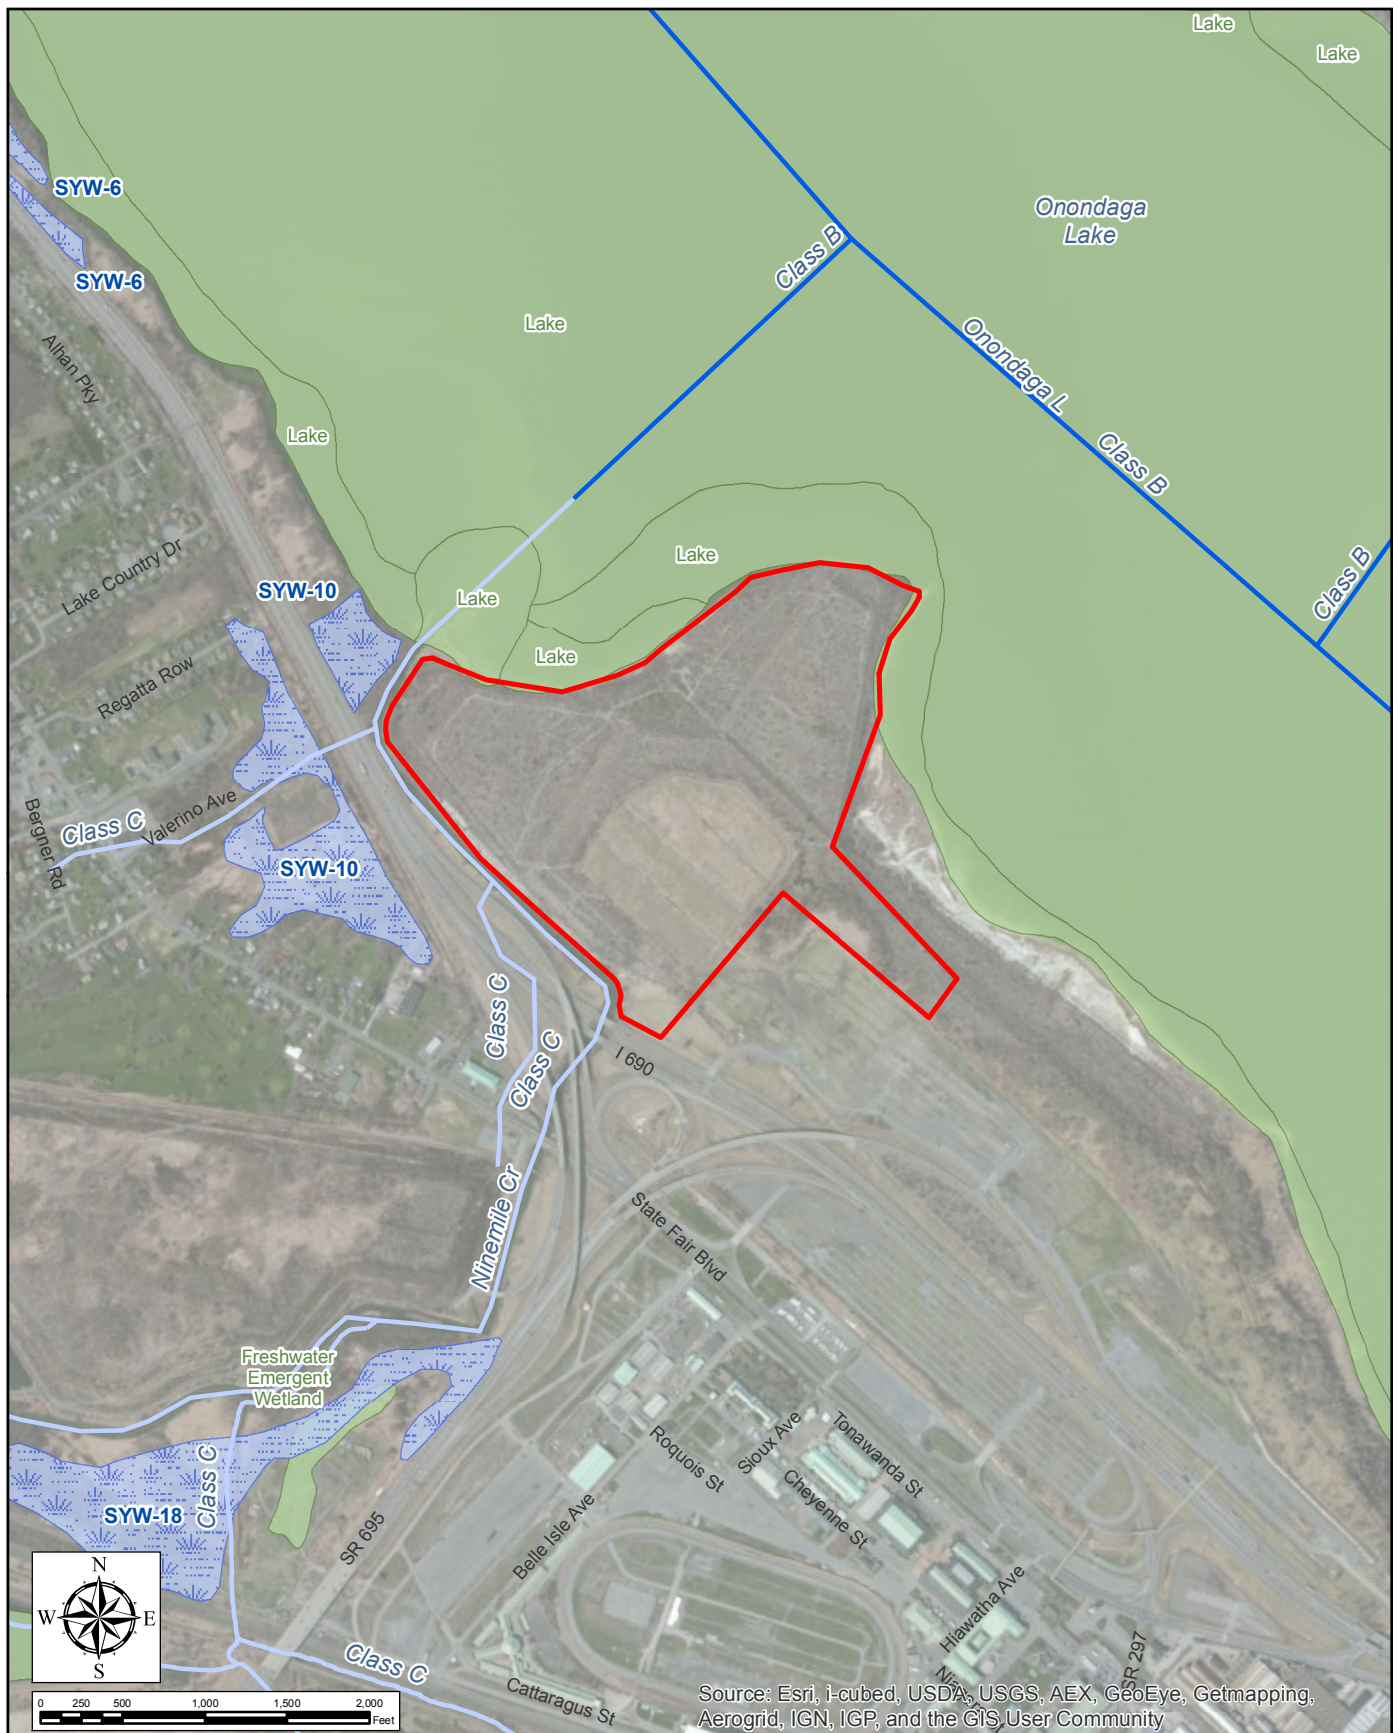
FIGURE 6: MAPPED STREAMS AND WETLANDS

- NYSDEC PROTECTED STREAM
- UNPROTECTED STREAM
- NYSDEC WETLAND
- NWI WETLAND
- PROJECT SITE

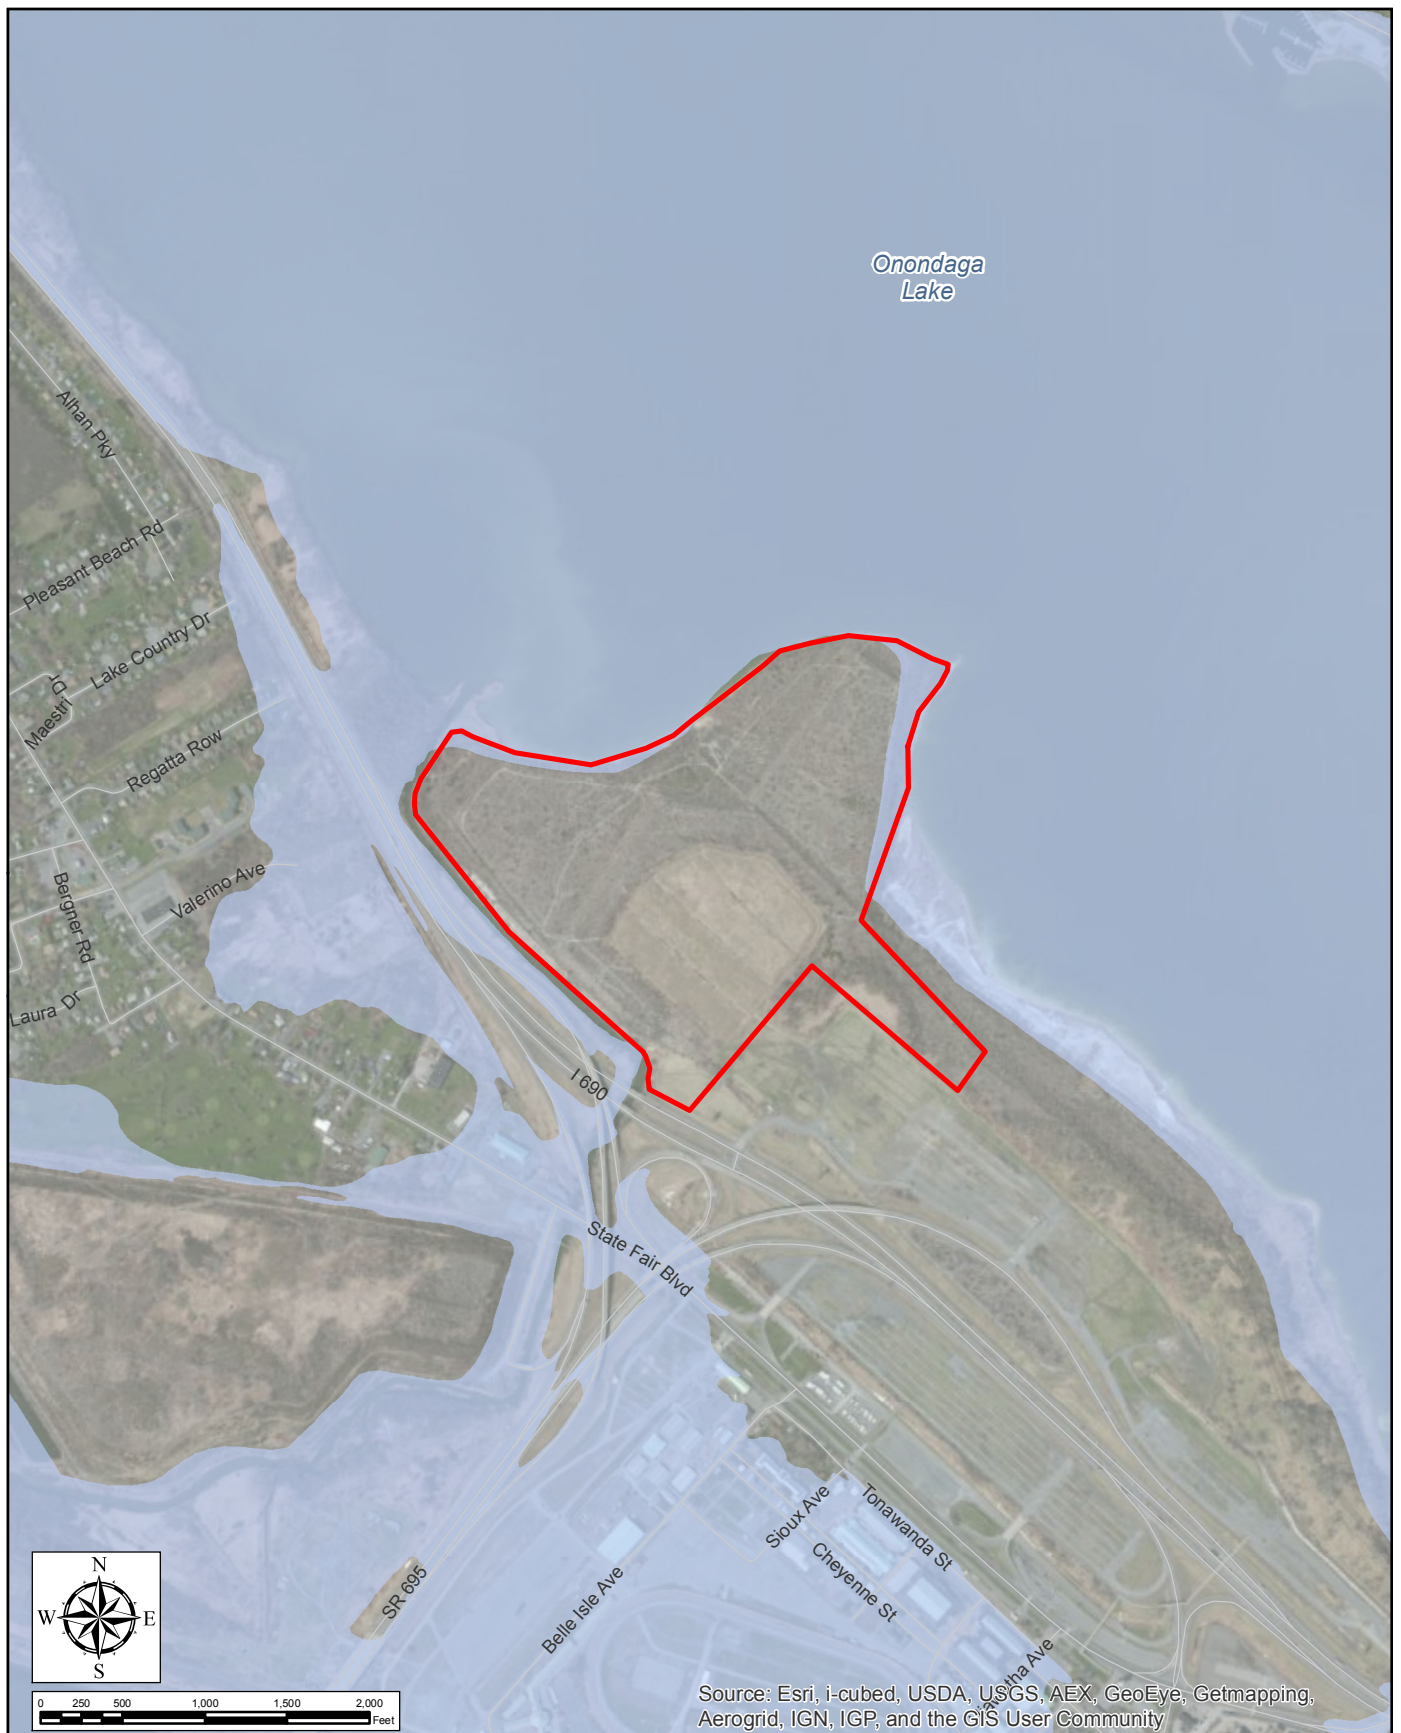
FIGURE 7: MAPPED FLOODPLAINS

- FEMA 100-YEAR FLOODPLAIN
- PROJECT SITE

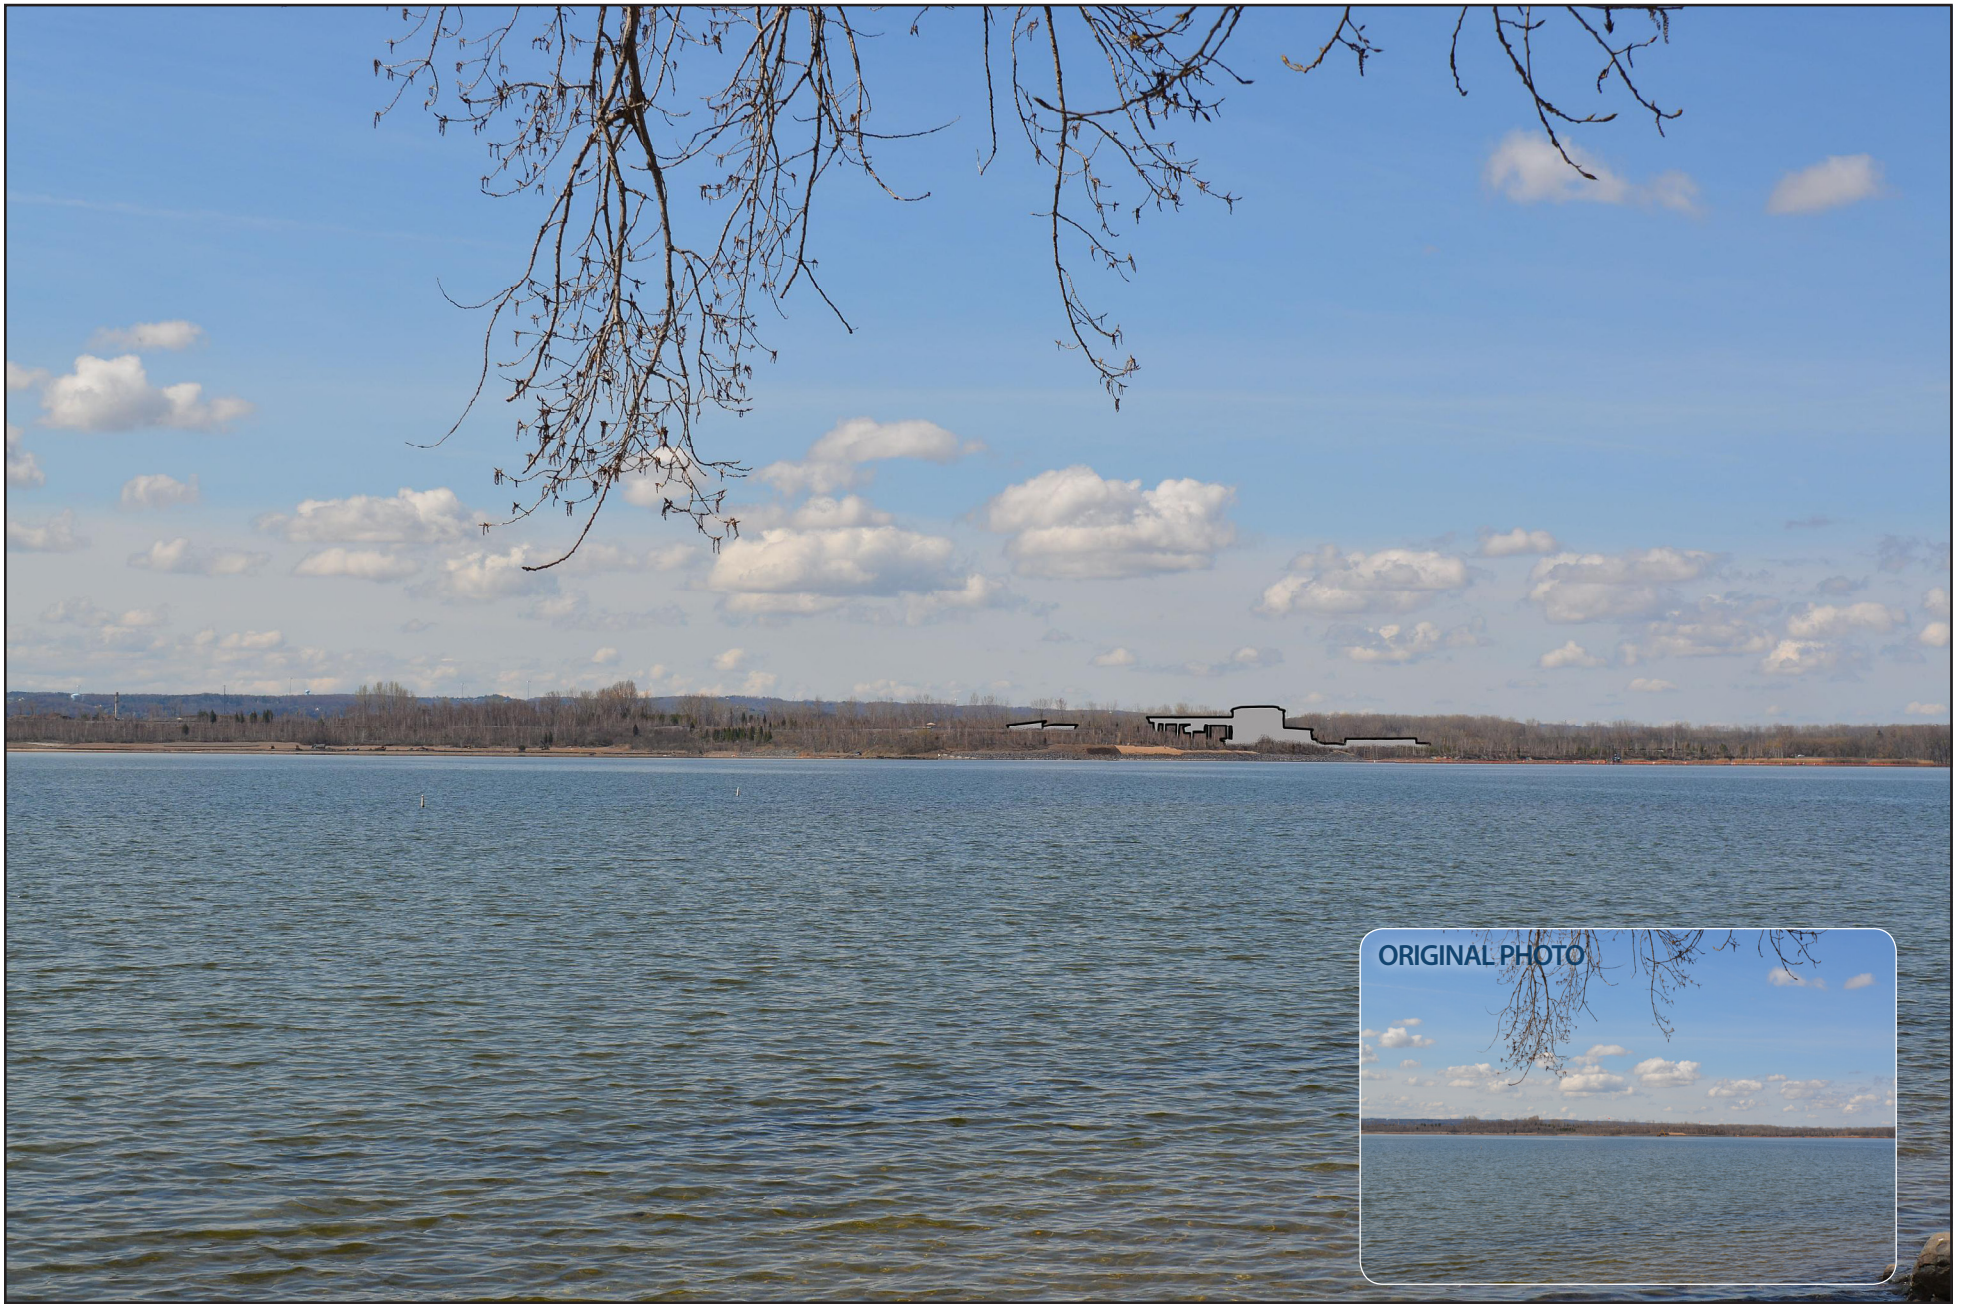
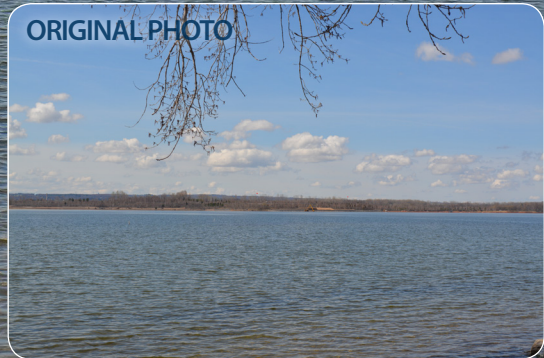
Please note that the purpose of creating a wire frame model is to determine the scale of a given building/structure based on the conceptual design, and its placement and orientation in a given landscape. The building finishes and aesthetic qualities will ultimately be determined through detailed architectural design.

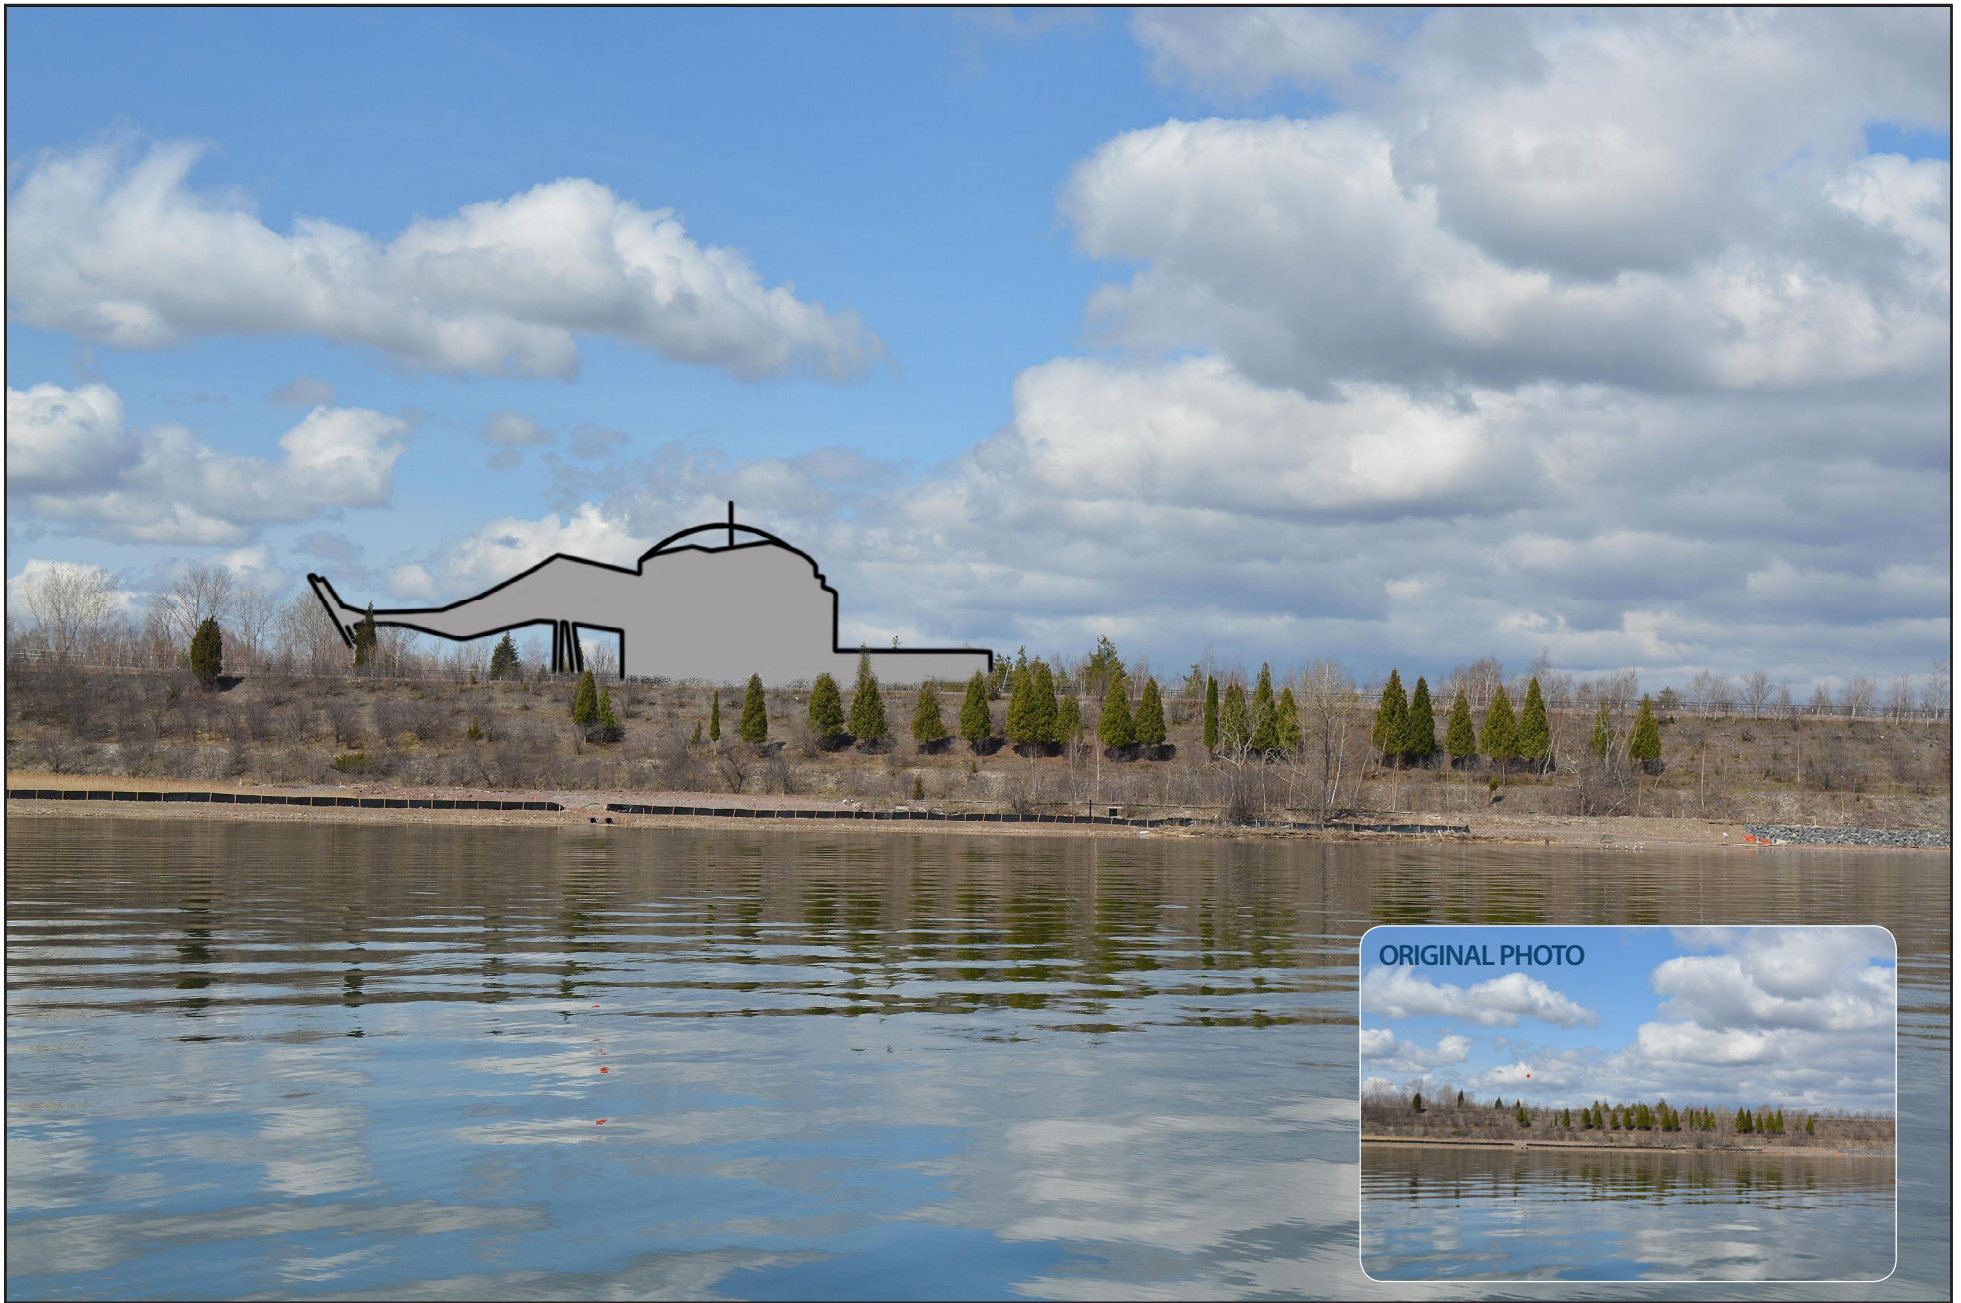
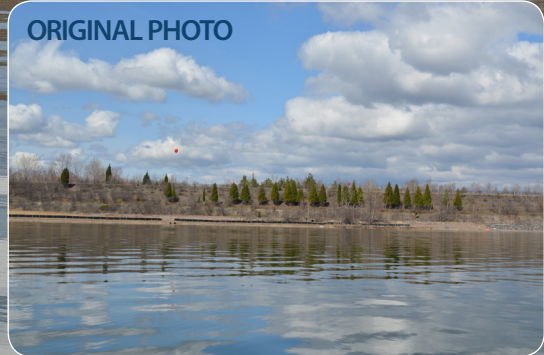
Please note that the purpose of creating a wire frame model is to determine the scale of a given building/structure based on the conceptual design, and its placement and orientation in a given landscape. The building finishes and aesthetic qualities will ultimately be determined through detailed architectural design.

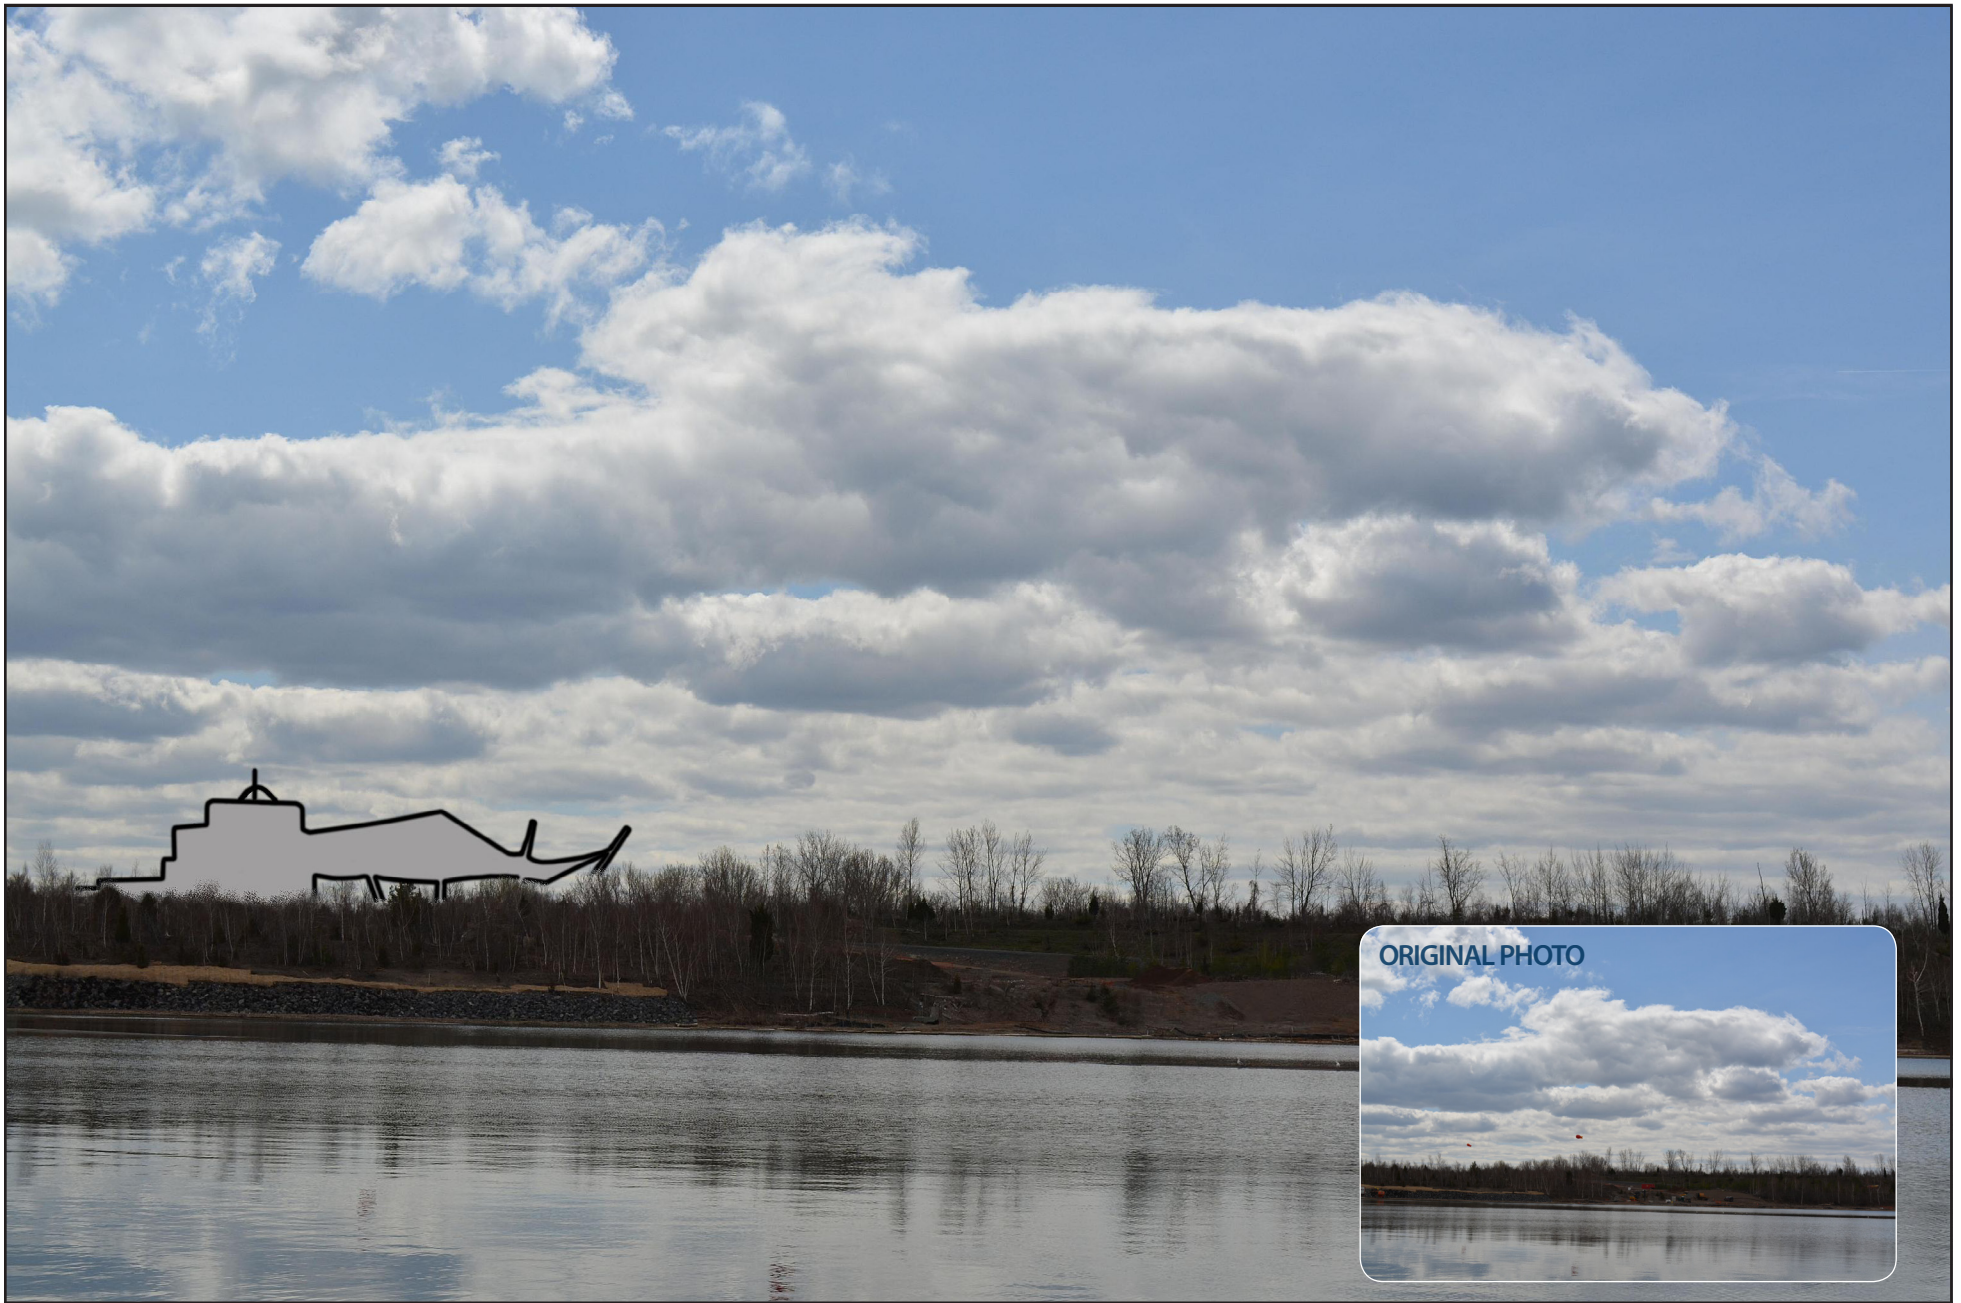
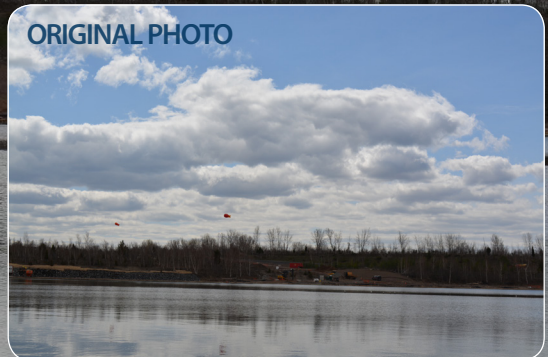
Please note that the purpose of creating a wire frame model is to determine the scale of a given building/structure based on the conceptual design, and its placement and orientation in a given landscape. The building finishes and aesthetic qualities will ultimately be determined through detailed architectural design.

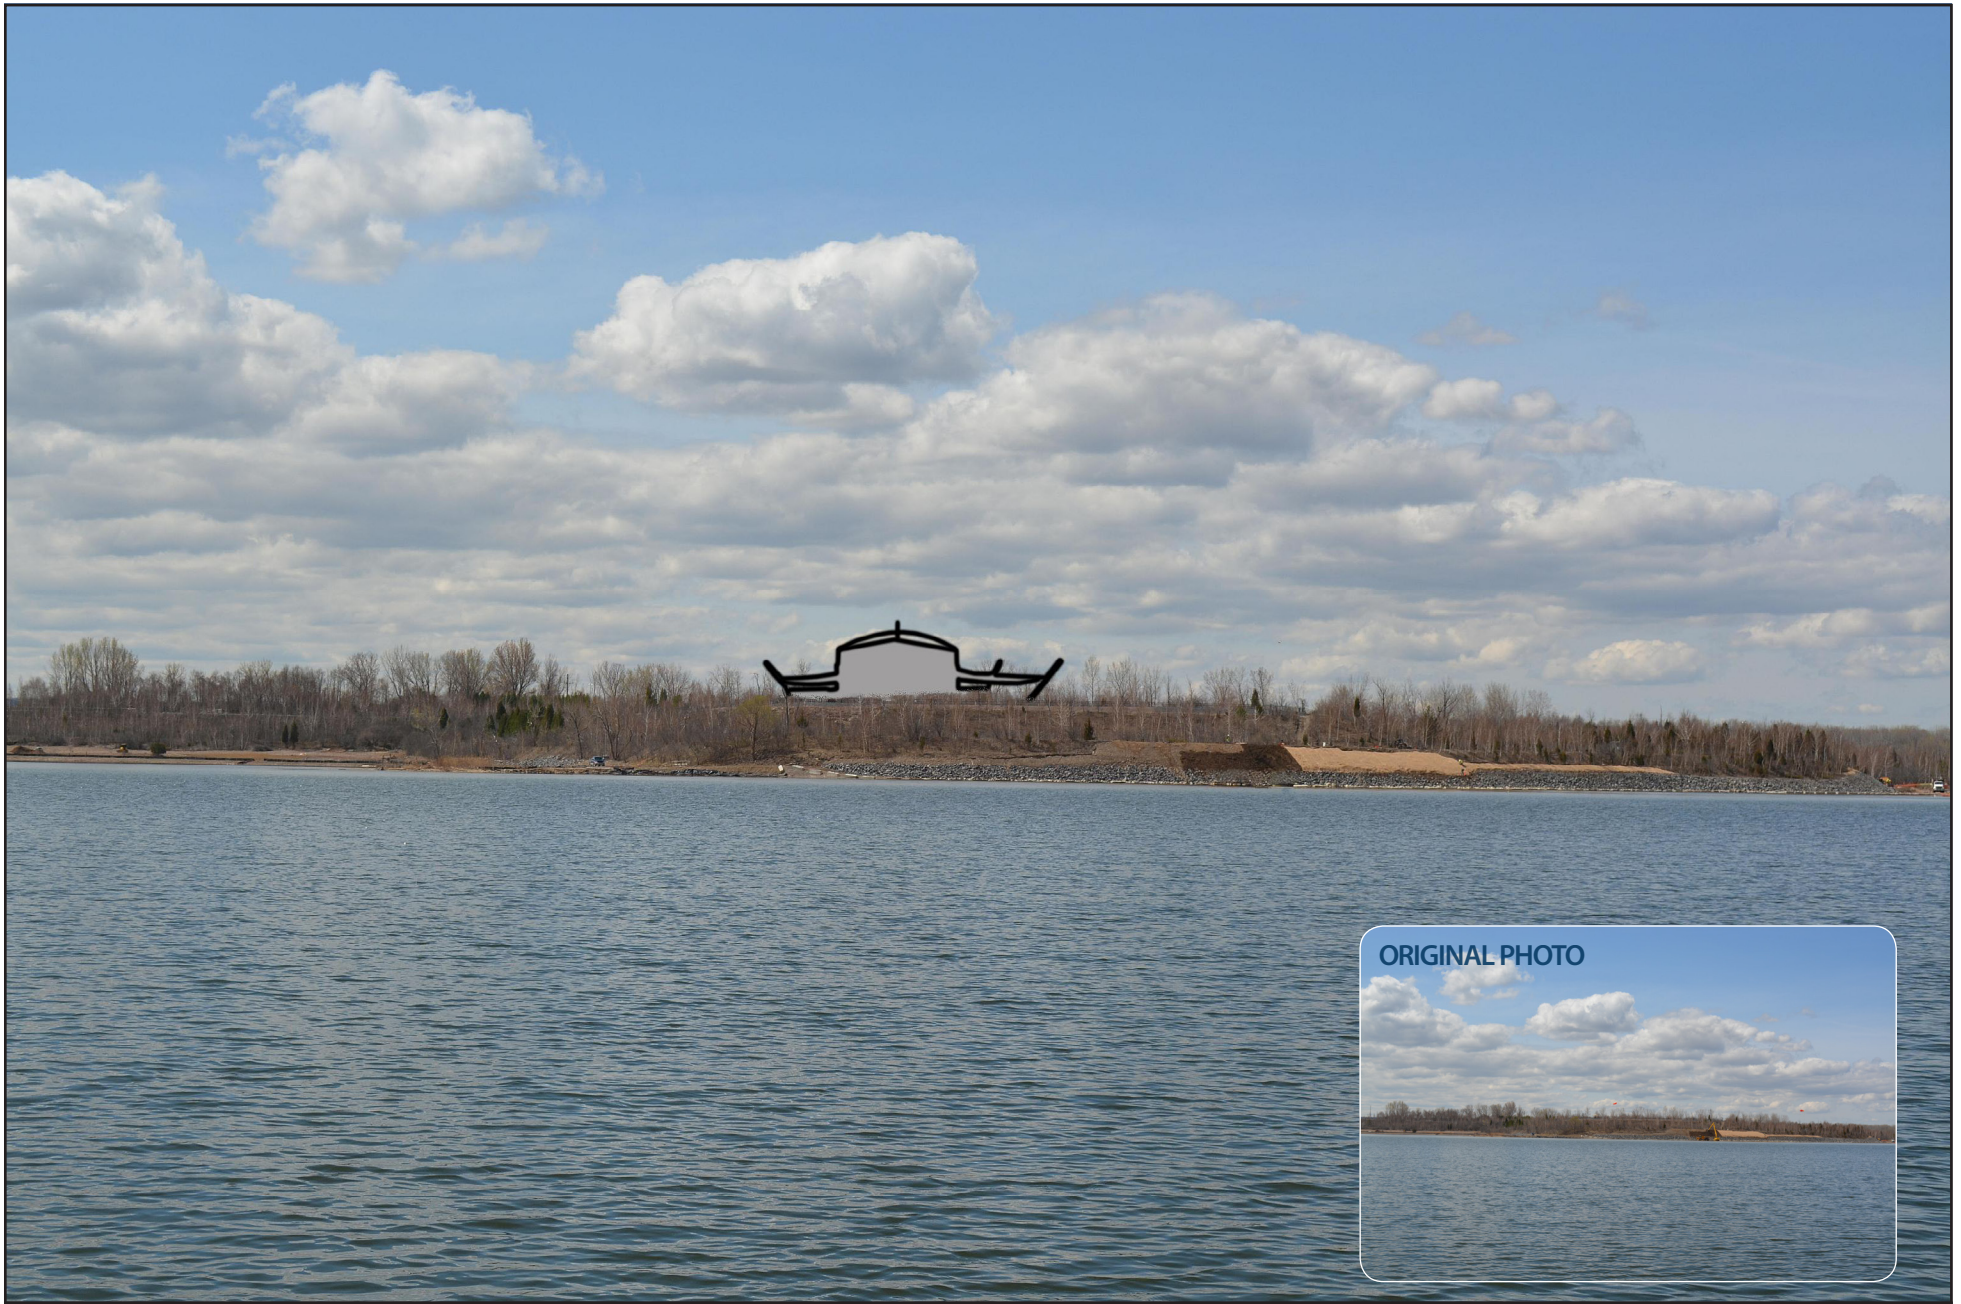
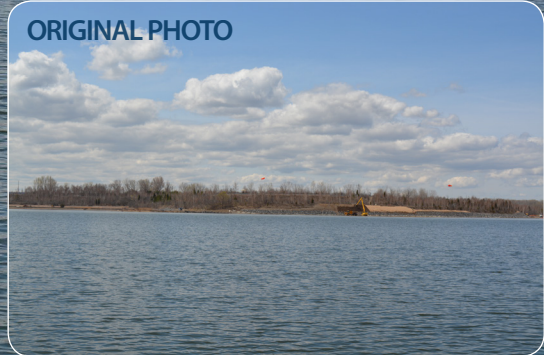
Please note that the purpose of creating a wire frame model is to determine the scale of a given building/structure based on the conceptual design, and its placement and orientation in a given landscape. The building finishes and aesthetic qualities will ultimately be determined through detailed architectural design.

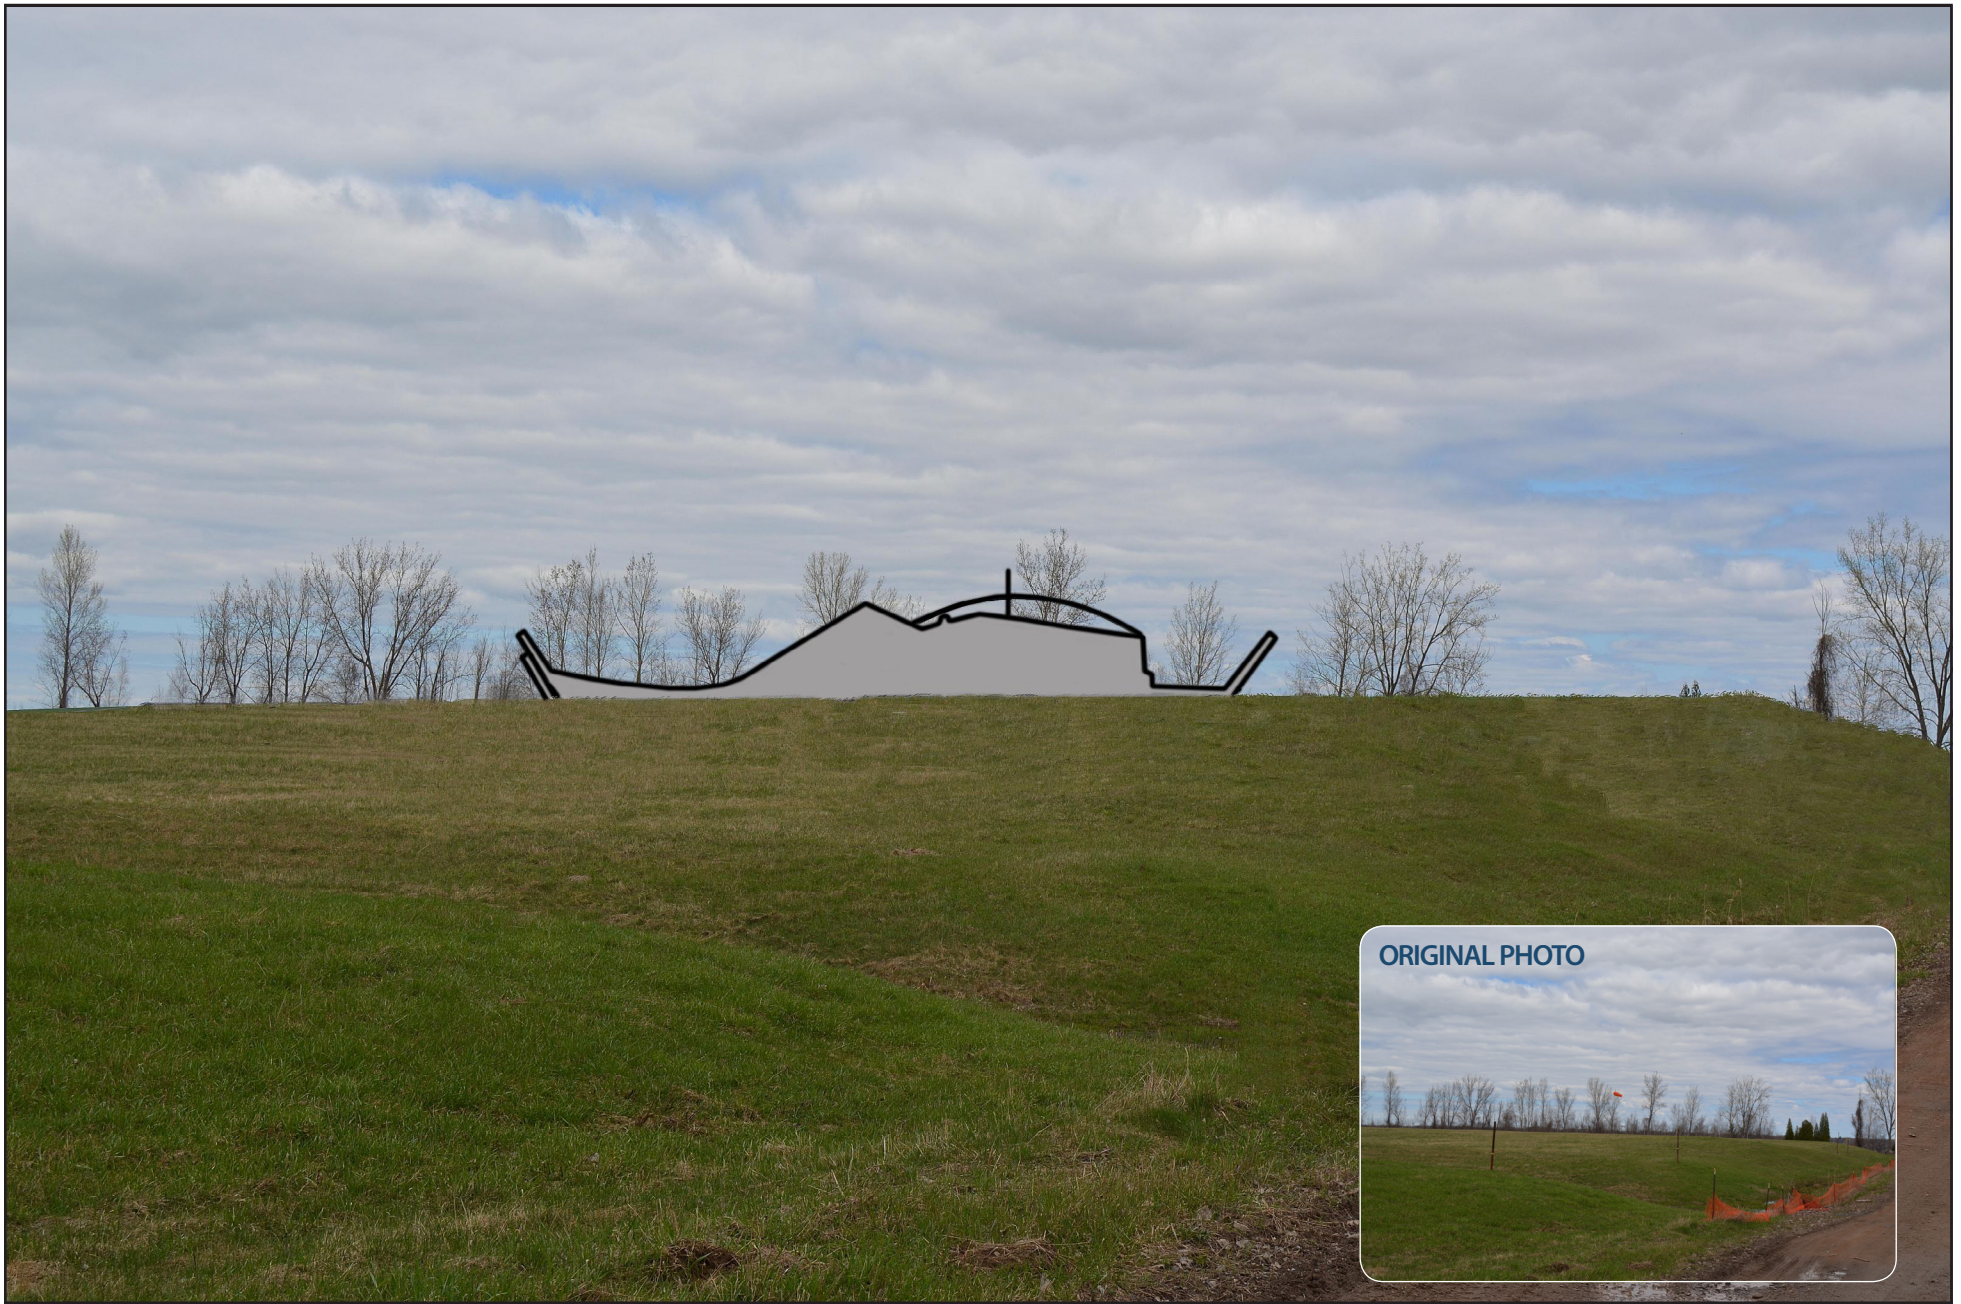
FIGURE 17: VIEWPOINT 24 WIRE FRAME RENDERINGS

Please note that the purpose of creating a wire frame model is to determine the scale of a given building/structure based on the conceptual design, and its placement and orientation in a given landscape. The building finishes and aesthetic qualities will ultimately be determined through detailed architectural design.
