Lakeview Amphitheater

Draft Environmental
Impact Statement

SEQR Lead Agency:
Onondaga County

June 2014

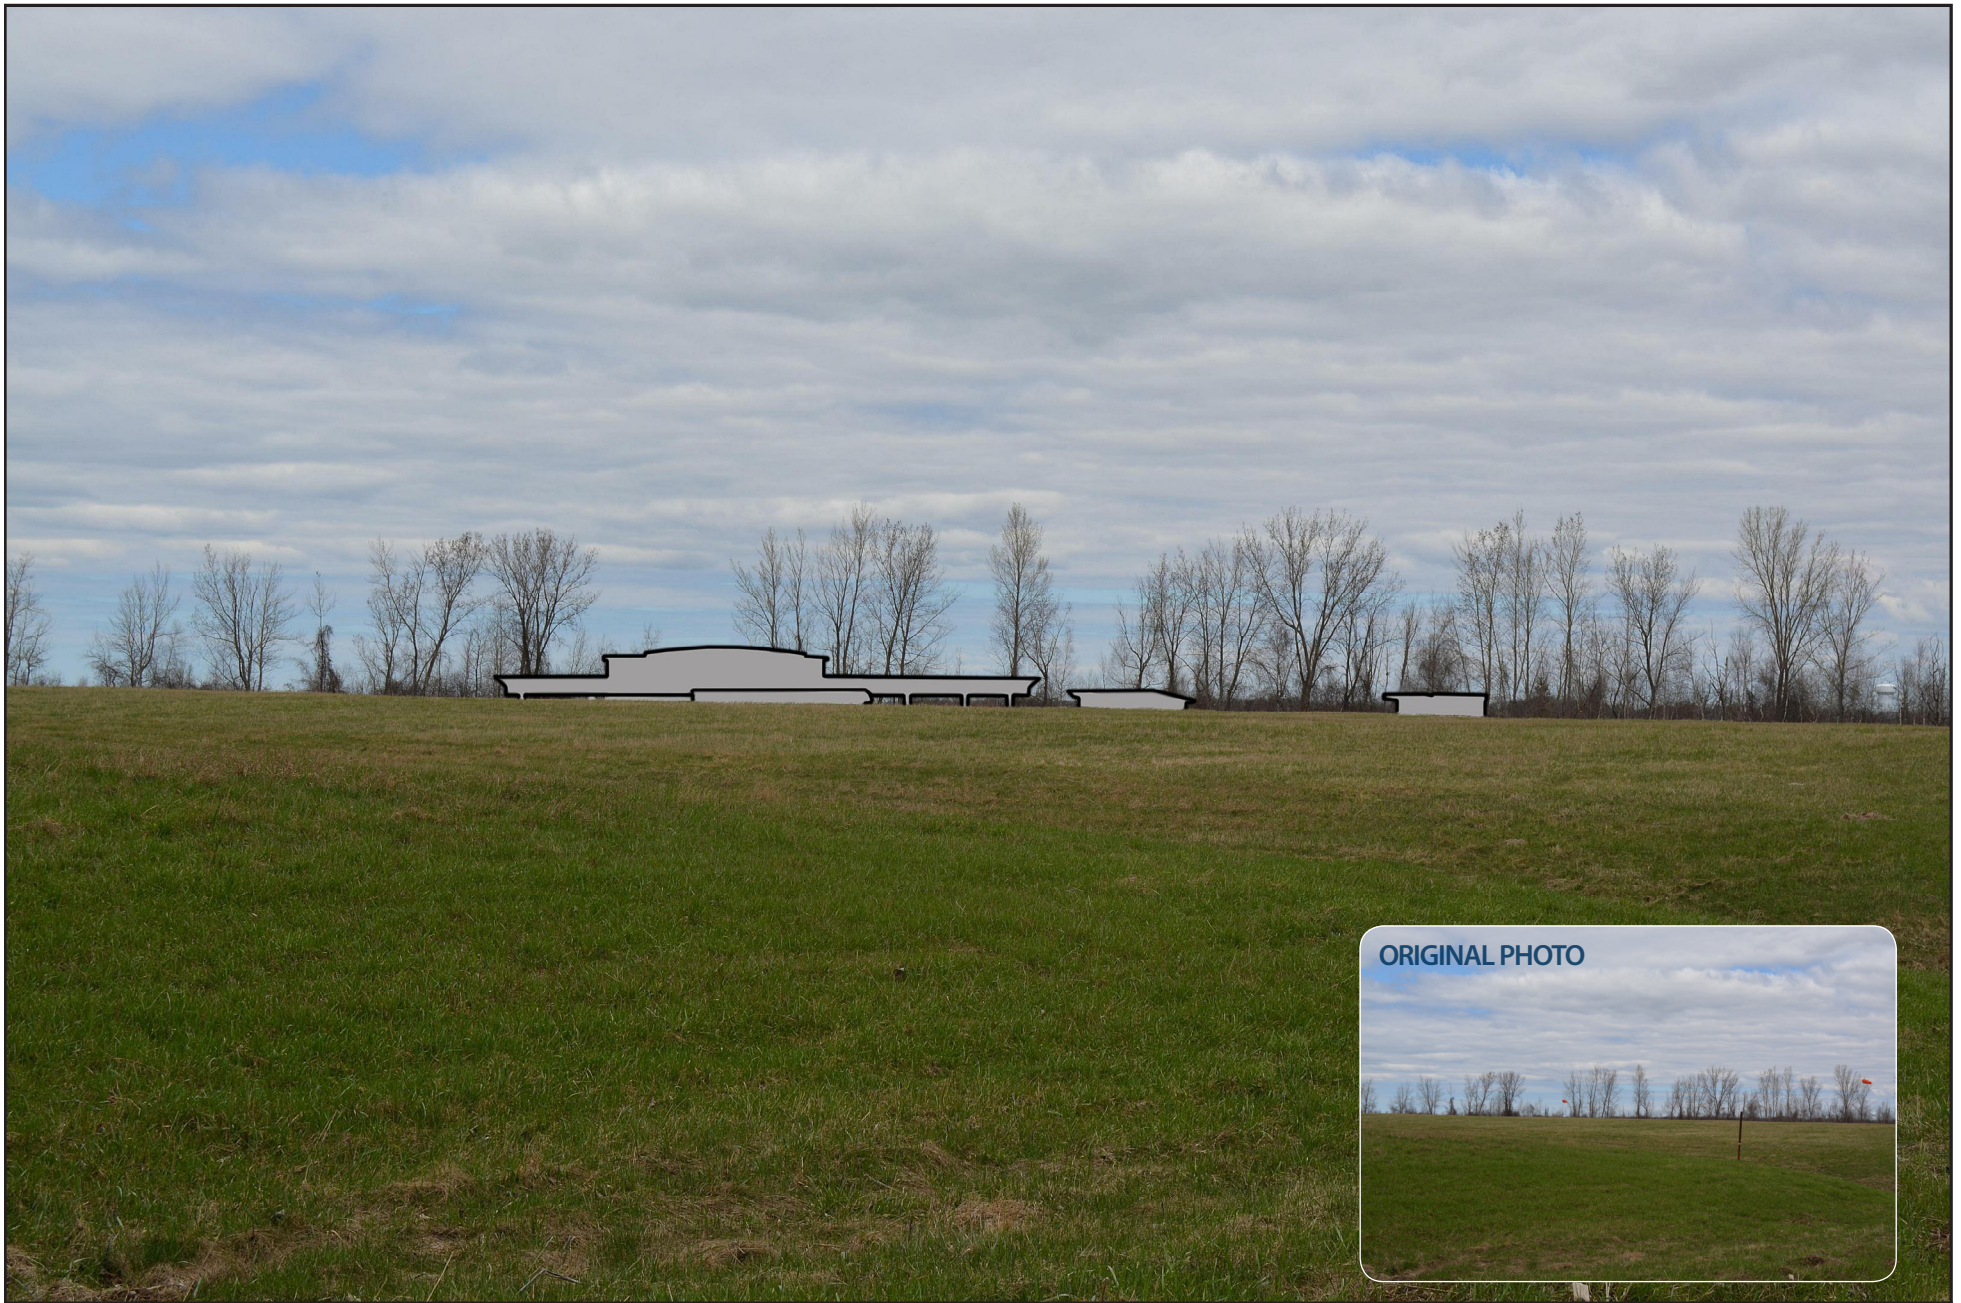
FIGURE 17: VIEWPOINT 24 WIRE FRAME RENDERINGS

Please note that the purpose of creating a wire frame model is to determine the scale of a given building/structure based on the conceptual design, and its placement and orientation in a given landscape. The building finishes and aesthetic qualities will ultimately be determined through detailed architectural design.

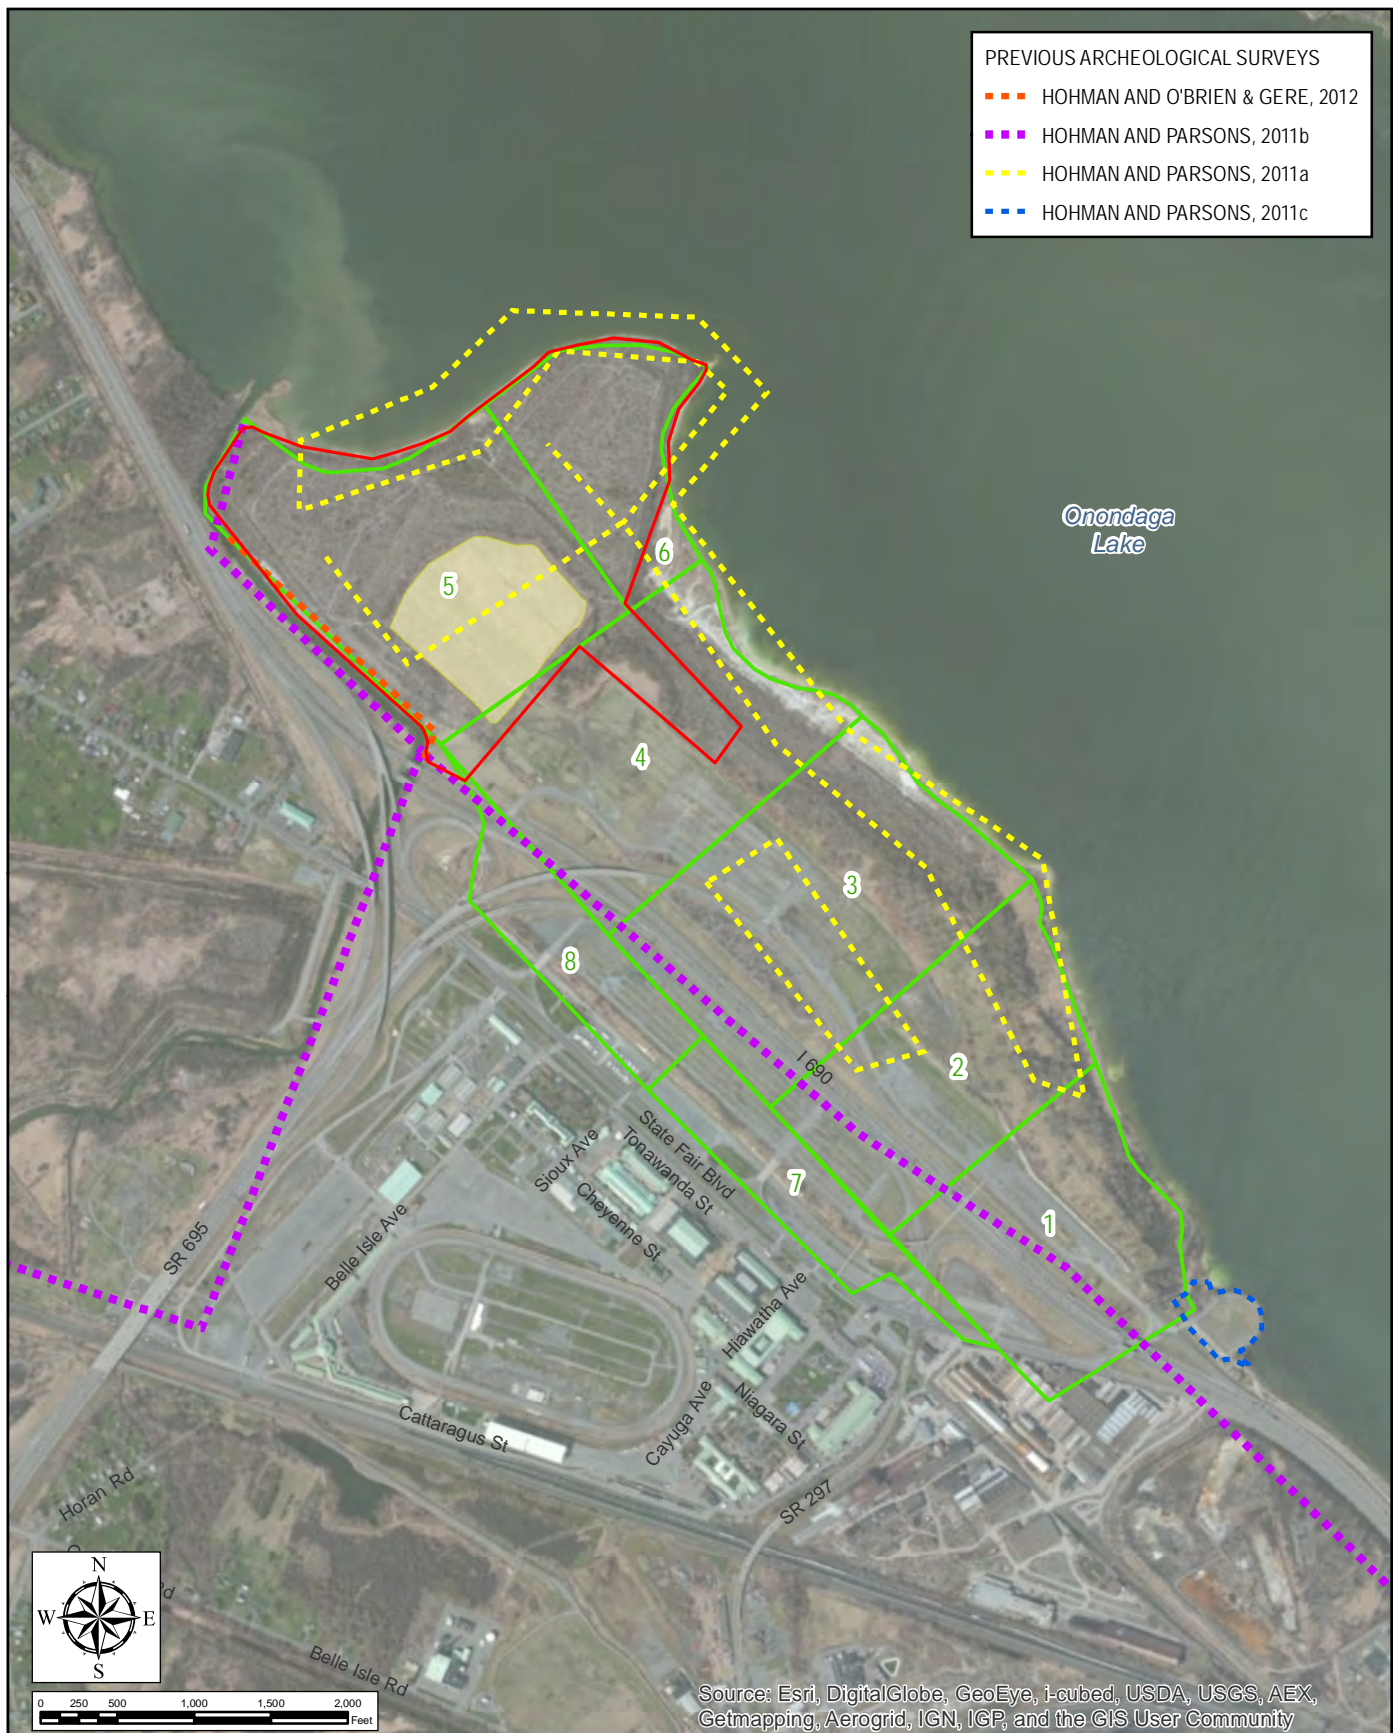
FIGURE 18: PREVIOUS ARCHEOLOGICAL SURVEYS

- CRUCIBLE LANDFILL
- SOLVAY WASTEBED
- PROJECT SITE

A Phase 1B archeological survey of Wastebeds 1-8 was conducted in 2010 (Hohman and Parsons, 2011a; see Figure 18). The Phase 1B survey included review of the geomorphological assessment, a complete site walkover reconnaissance, analysis of soil borings, and the excavation of 19 shovel tests along the shoreline of the lake. In most portions of Wastebeds 1-8, the study found that approximately 65 to 70 feet of waste and fill were located above a natural horizon of peat and marl soils. Solvay Process Waste deposits were observed in all of the shovel tests excavated along the shoreline areas. In two shovel tests, apparently natural soils were observed below an approximately 1-foot-thick layer of Solvay Process Waste. These soils consisted of an 8 to 14-inch thick layer of gray marl (or peat) underlain by dark grayish brown sandy loam. No cultural resources were identified.

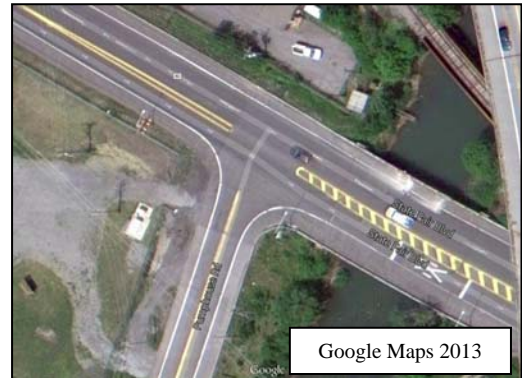
Intersection of State Fair Boulevard and Pumphouse Road is stop-controlled on Pumphouse Road. There are two lanes on the westbound approach and one lane on the eastbound approach of State Fair Boulevard with a narrow striped median and one approach lane on Pumphouse Road. There are no sidewalks or crosswalks, but paved shoulders are available on all roadway approaches.

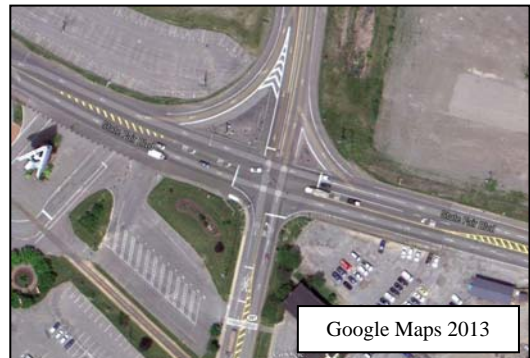
Intersection of State Fair Boulevard and Bridge Street (NYS RT 297) is four-way intersection that is controlled by a NYSDOT owned and operated signal. The approaches consist of the following lane configurations:

- State Fair Boulevard Eastbound – Dedicated left-turn lane, through lane, and shared through/right-turn lane
- State Fair Boulevard Westbound – Dedicated left-turn lane, through lane, and shared through/channelized right-turn lane
- Bridge Street Northbound – Dedicated left-turn lane, shared through/right-turn lane
- I-690 Eastbound off-ramp – shared left-turn/through lane and channelized right-turn lane

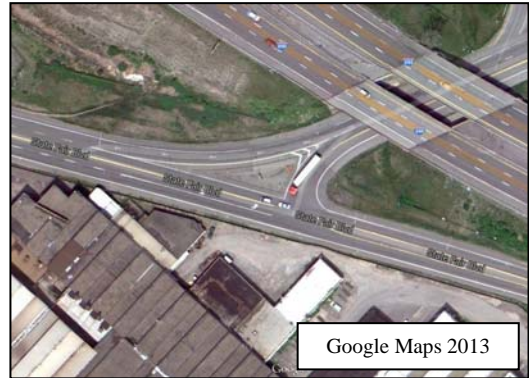
Intersection of State Fair Boulevard and the Exit 7 Connector road is a skewed three-way intersection that is stop controlled on the southbound approach of the connector road. There is one lane for left-turning traffic and one channelized right-turn lane for southbound traffic on the connector road. There is one lane for westbound traffic and a dedicated left-turn lane with a dedicated through lane for eastbound traffic on State Fair Boulevard.

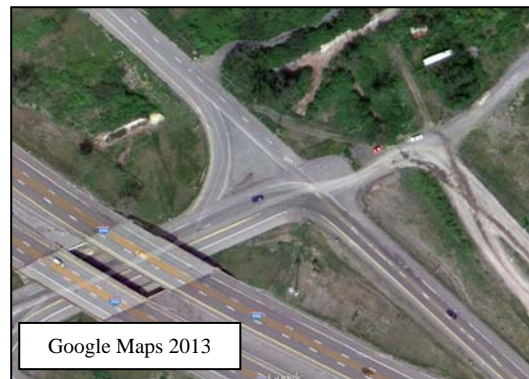
Intersection of the Exit 7 Connector and the I-690 Westbound Exit 7 Off-Ramp is a four-way intersection that is controlled on all approaches but the Exit 7 off-ramp. The off-ramp consists of two-lanes that operate as a dedicated left-turn lane and shared left-turn/through/right-turn lane during typical operations. The access to the State Fair Orange Lot is opposite the Exit 7 off-ramp and consists of two lanes inbound and one channelized right-turn lane approaching the intersection. The Exit 7 Connector road approach is one shared left-turn/through lane. The approach opposite the Exit 7 Connector is currently provides construction access to sites along Onondaga Lake.

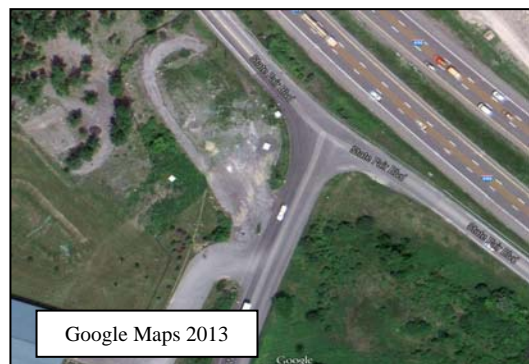
Intersection of State Fair Boulevard and Willis Avenue is a three-legged intersection with stop-control on Willis Avenue. Each approach consists of one lane for all movements.

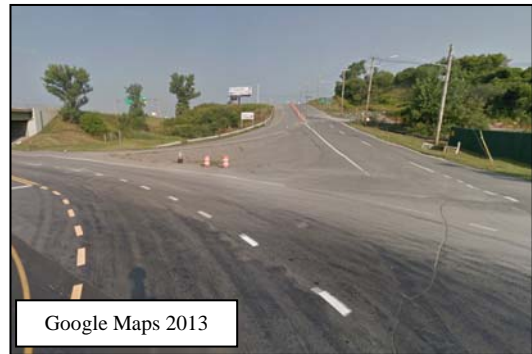
The Orange Lot is accessed via a three-lane roadway opposite the I-690 Westbound Exit 7 off-ramp and is estimated to be able to accommodate approximately 6,500 vehicles. This access will serve as the only vehicular access to the site. It is anticipated that

the existing grade approaching the facility site will be reduced as part of the development of the site.

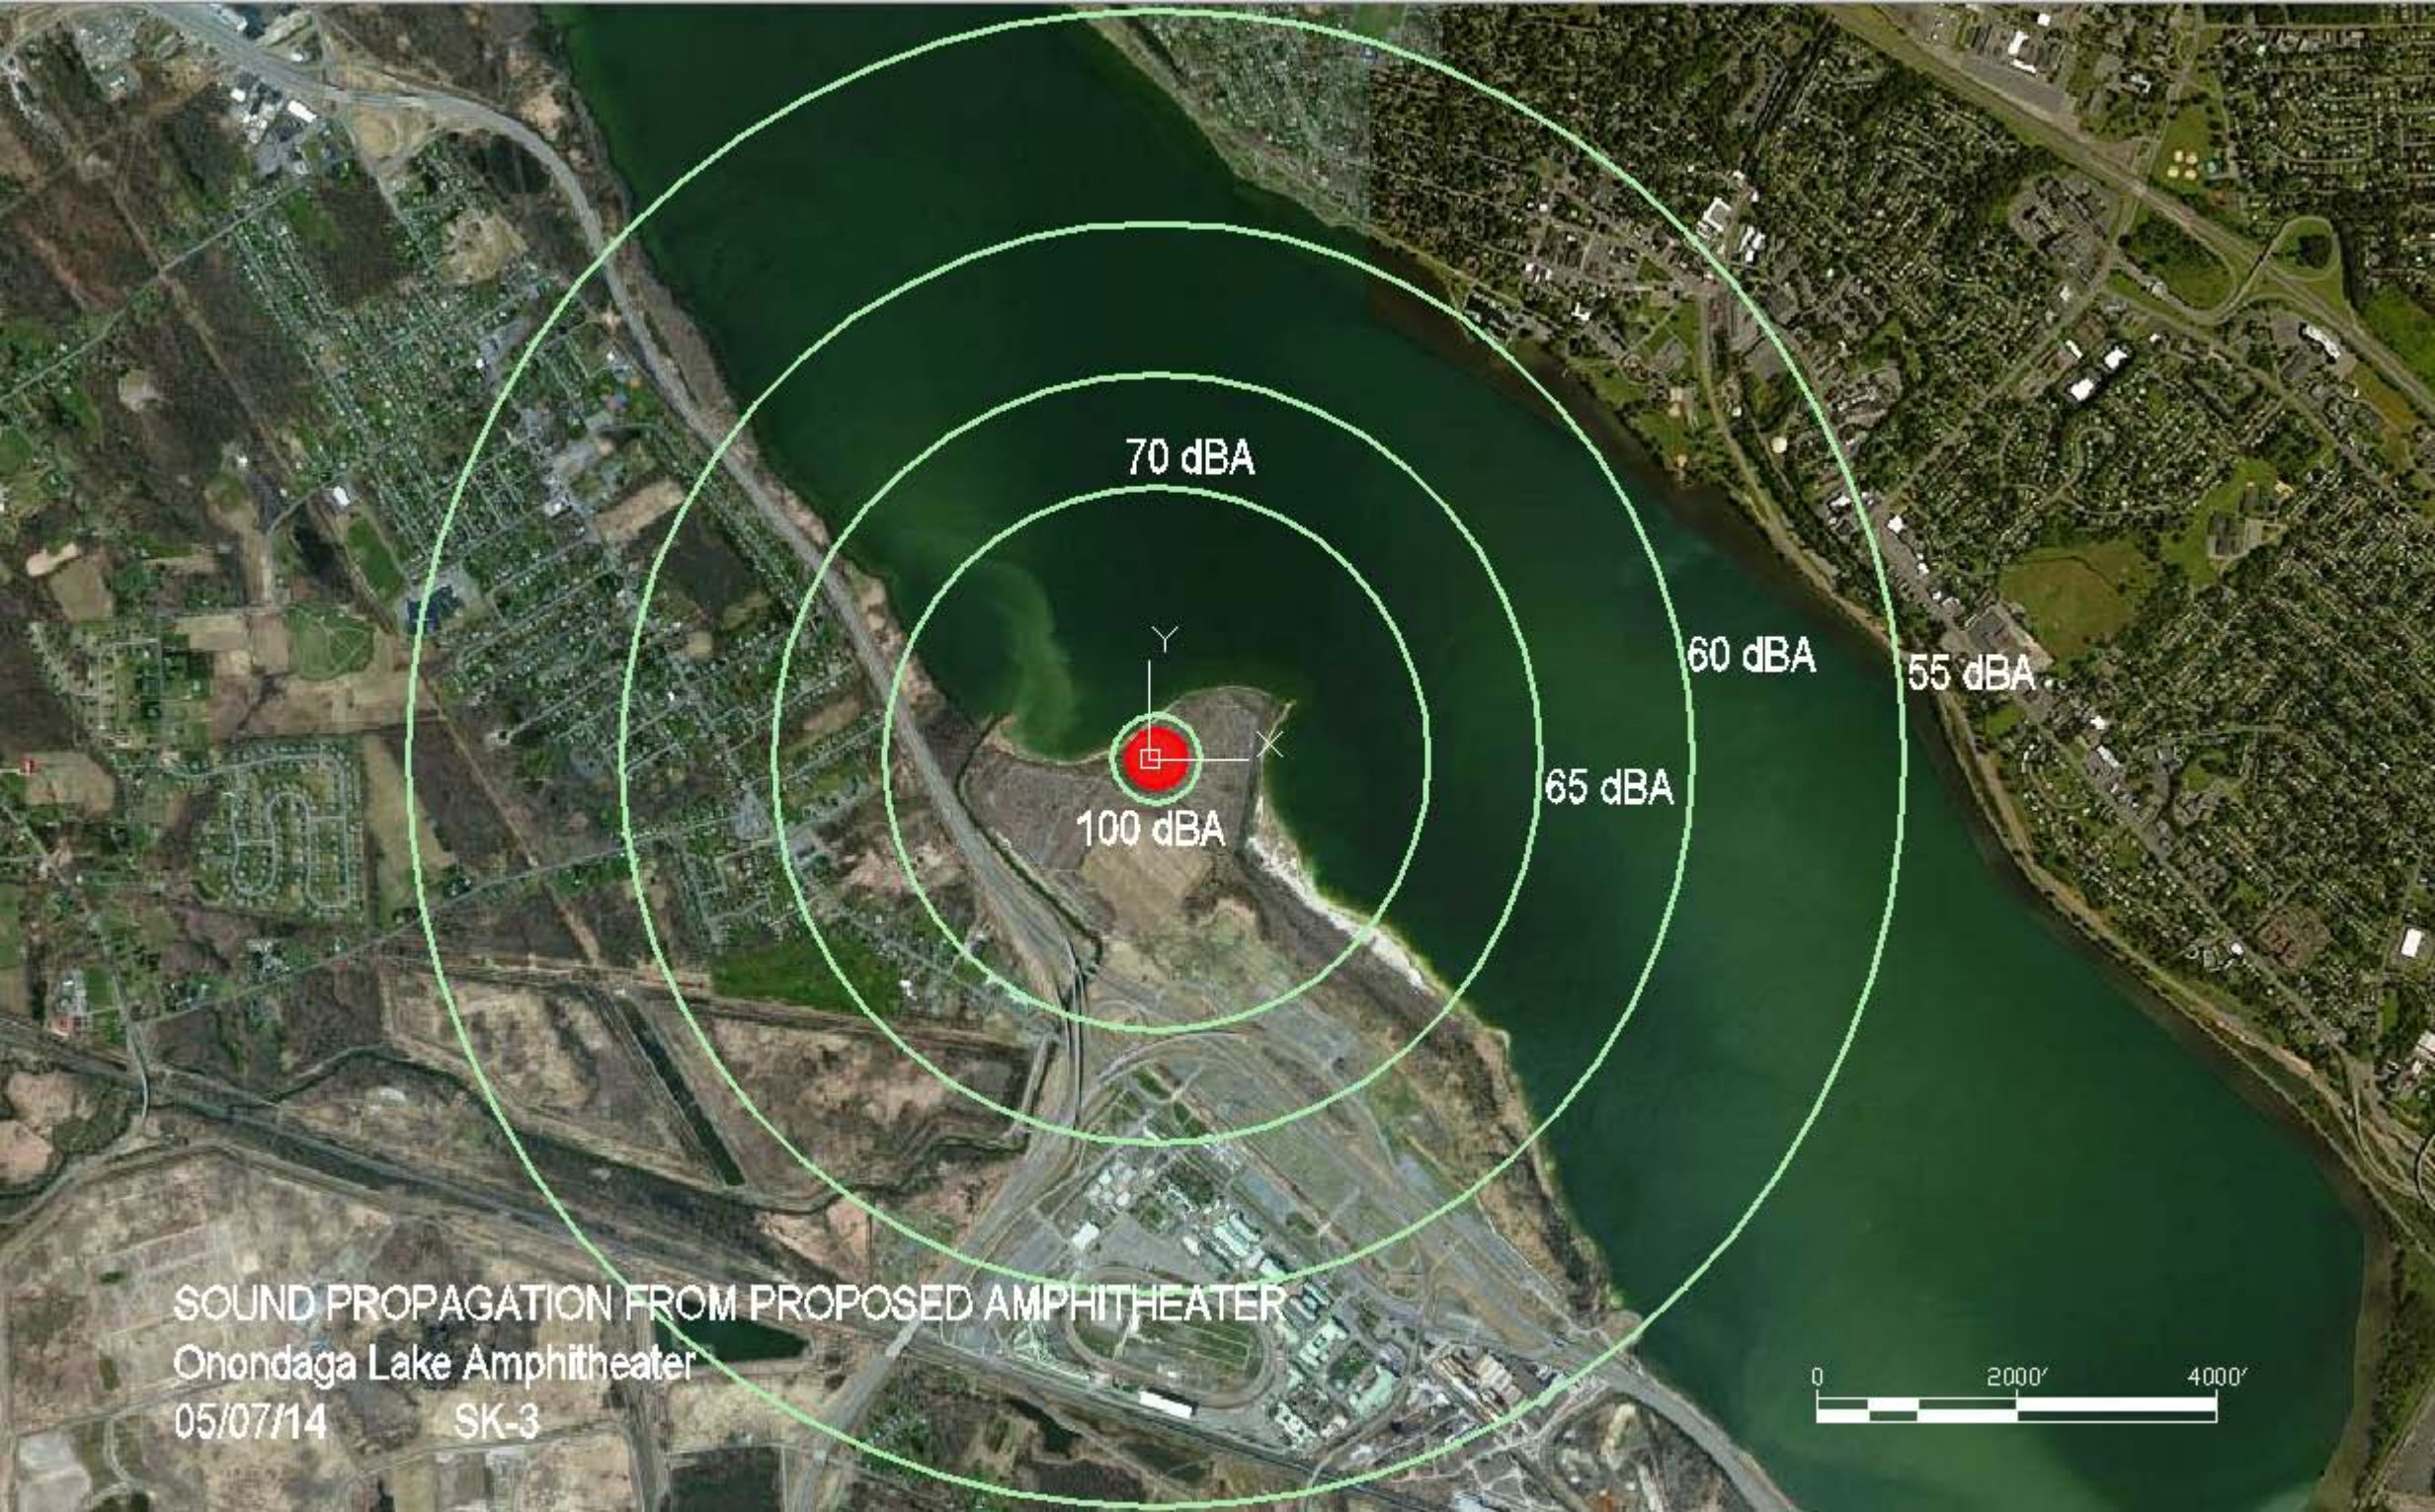
SOUND PROPAGATION FROM PROPOSED AMPHITHEATER

SK-3 shows the anticipated maximum sound levels within approximately 2 miles of the Amphitheater location. Note that there are residential areas in which we expect maximum sound levels from some events to exceed 65 dBA. SK-4 compares expected maximum sound levels from concerts in the proposed Amphitheater with expected maximum sound level from concerts in the existing State Fair Grandstand.
