## 5.4.4 Geological Hazards

### 5.4.4.1 Hazard Profile

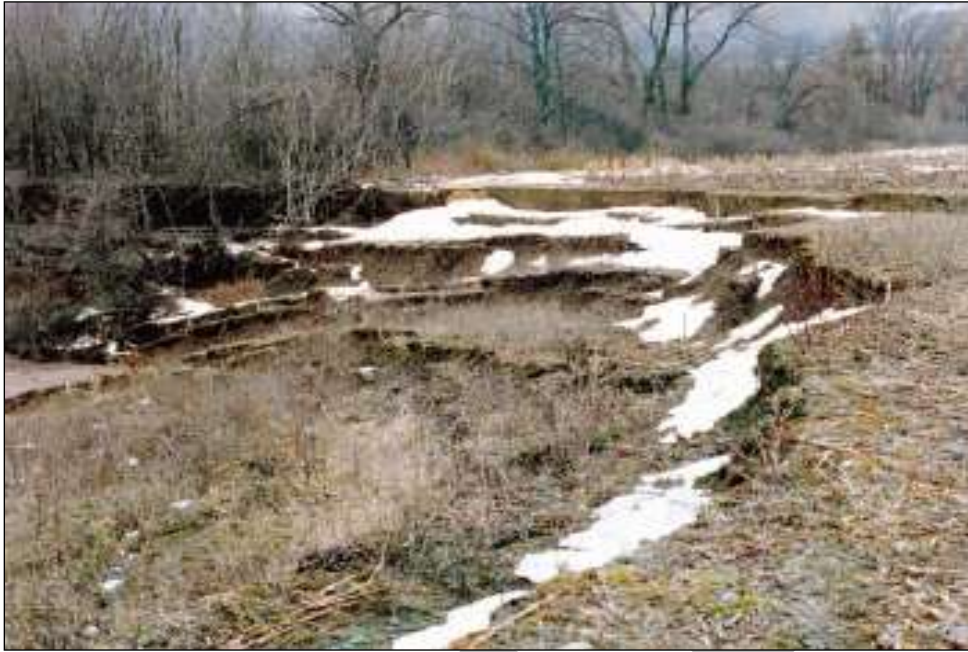
Figure 5.4.4-2. Mudboil/Depression Area in the Tully Valley

Another, less common cause of land subsidence is a natural phenomenon known as mudboils. Mudboils are volcano-like cones of fine sand and silt that range from several inches to several feet high and from several inches to more than 30 feet in diameter. Active mudboils are dynamic ebb-and-flow features that can erupt and form a large cone in several days, then cease flowing, or they may discharge continuously for several years. Mudboils continuously discharge sediment-laden (turbid) water, pulling sediments from the subsurface, which can lead to gradual land subsidence (Kappel and McPherson, 1998; Kappel et al., 1996).

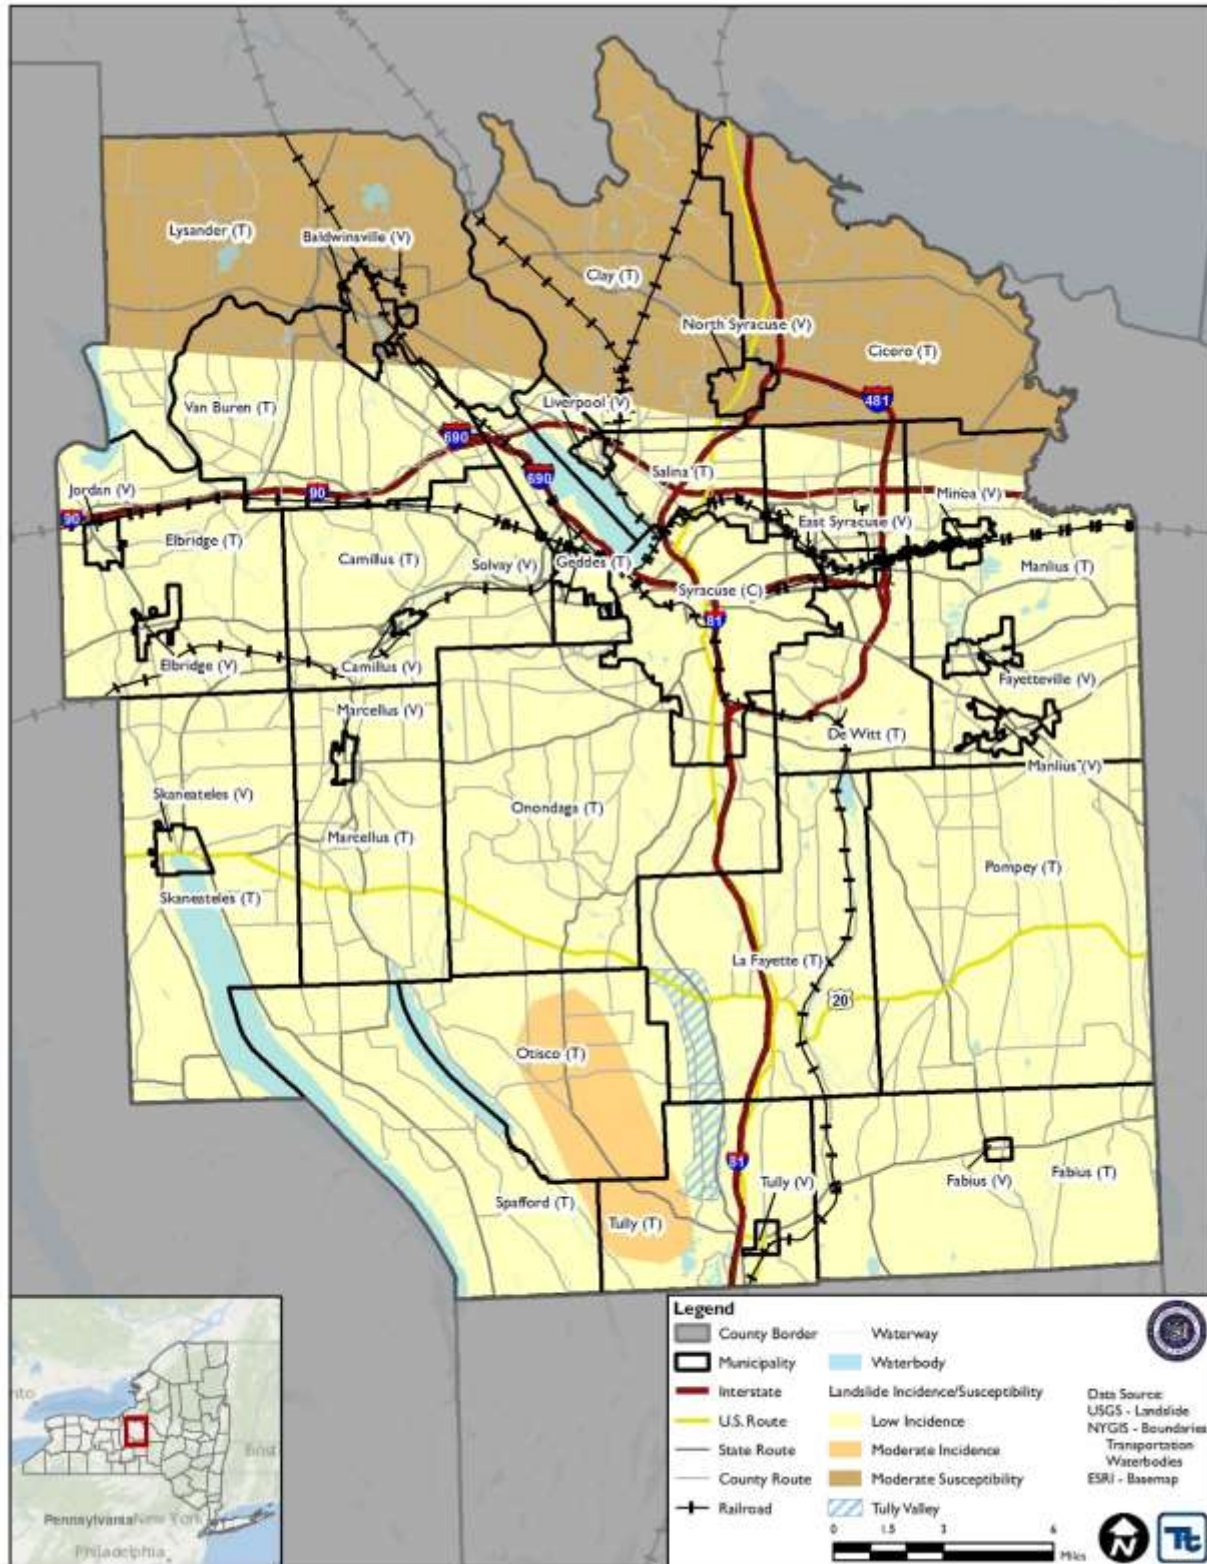
Figure 5.4.4-3. Landslide Susceptibility in Onondaga County

Note: According to this figure, the northern portion of the county is located within the moderate susceptibility to landsliding with the remainder of the county having low landslide incidence. There is a small portion of the county with moderate landslide susceptibility in the southern portion of the county.

The potential for landslides exists across New York State; however, 80-percent of the state has a low susceptibility of landslides. Figure 5.4.4-3 indicates that a majority of Onondaga County has low incidence of landslides. The northern portion of the county is shown as having moderate susceptibility to landsliding and low incidence of occurrence. A small area in the center of the southern portion of the county has moderate incidence.

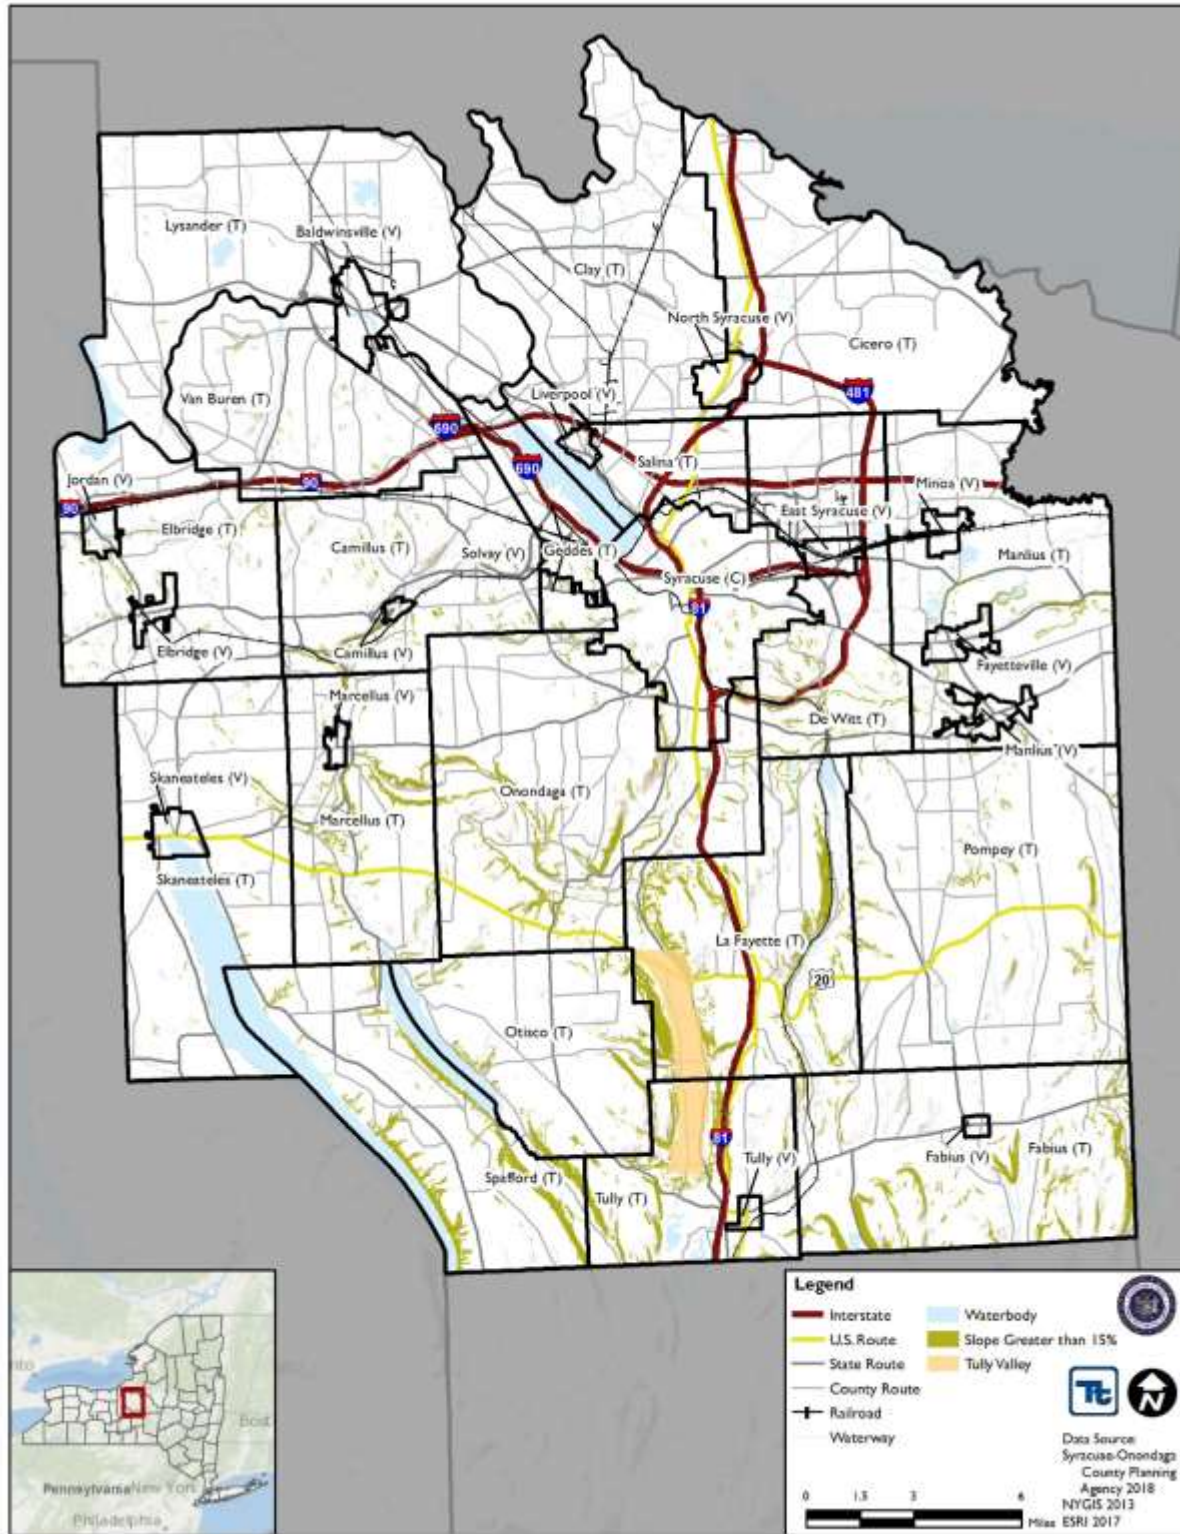
Figure 5.4.4-4. Steep Slope Areas in Onondaga County

Areas of steep slopes are typically at greatest risk for landslide occurrences. Figure 5.4.4-4 shows areas in Onondaga County with slopes greater than 15-percent. Areas of steeper slopes increase the likelihood that landslides will occur, especially during periods of heavy rain or human activity. However, the primary cause of landslides is the influence of gravity acting on weakened materials that make up a sloping area (Connors 2018; USGS 2004). The figure shows steep slope areas throughout Onondaga County, with many steep slopes located around the lakes in southwestern Onondaga County and areas in and around Tully Valley.

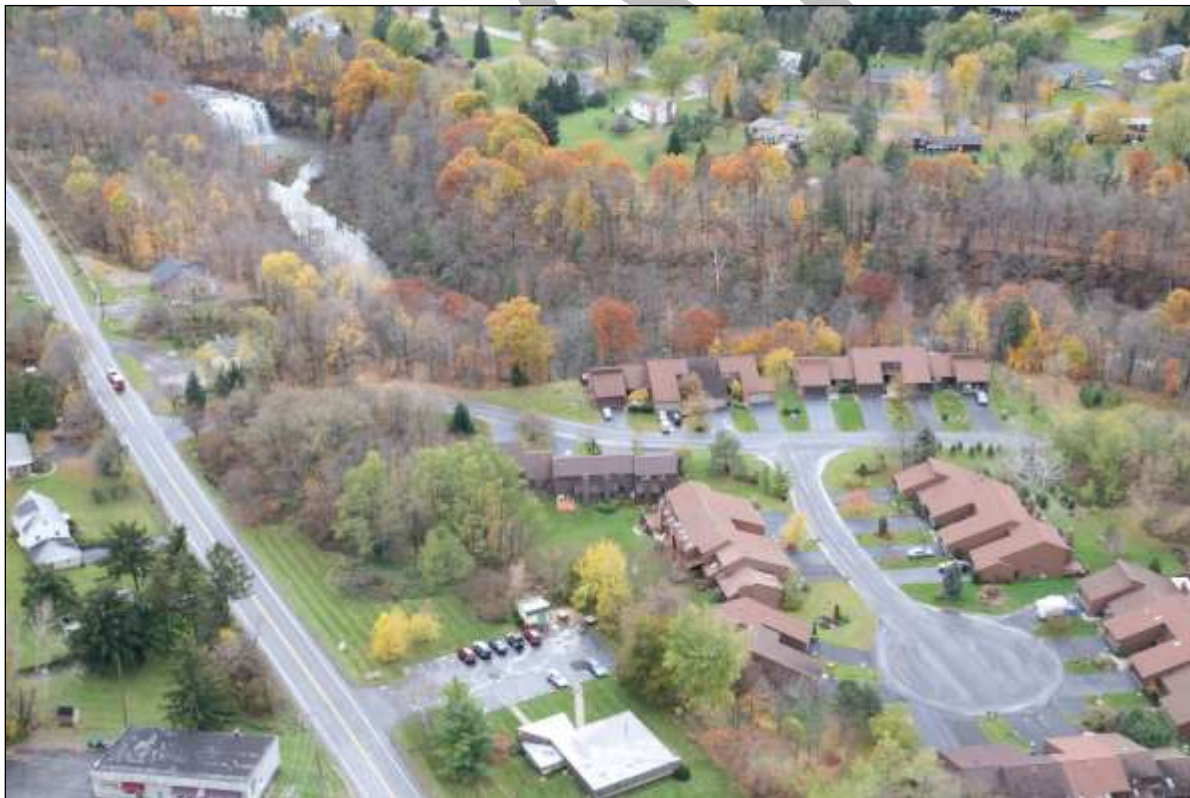
**Figure 5.4.4-6. Aerial Photograph of Limestone Creek and The Bluffs in Manlius on October 26, 2006**

The Bluffs (along Bluffview) in the Town of Manlius overlooking Limestone Creek have experienced geological hazard events in the past. According to an Engineering Feasibility Study conducted in 2005, four attached condominiums along Bluffview in the Town of Manlius were constructed (before 1994) close to the edge of an approximately 80-foot high bluff overlooking Limestone Creek (The Bluffs). In May 2002, an approximate 40-foot wide area of the bluff slid into Limestone Creek carrying the ground surrounding the south-side of condominium unit 8181. The earth slope failed after a heavy rain event. According to the study, a glacial till layer (fine-grained silt, sand, gravel, cobbles and boulders) supports the floors and footings of the condominiums and is susceptible to erosion by precipitation and roof runoff. The bedrock below the soil is ‘thinly bedded and fractured limestone that is susceptible to surface unraveling from weathering.’ The study also states that deeper large scale instability in the rock cannot be ruled out, and without repair the building’s structure will eventually suffer (John P. Stopen Engineering Partnership, 2005). Figure 5.4.4-6 shows an aerial photograph of Limestone Creek and the Bluffs in Manlius on October 26, 2006.

Landslides and other geologic hazards have the potential to destabilize the foundation of structures, which may result in monetary losses to businesses and residents. As seen along Limestone Creek and the Bluffs in Manlius, geological hazard events can expose the underlying bedrock adjacent to structures, which can erode and threaten the structural integrity and safety of the structure above. Table 5.4.4-3 summarizes the exposed building stock to the steep slope hazard areas by municipality, Table 5.4.4-4 summarizes the exposed building stock on carbonate bedrock by municipality, and Table 5.4.4-5 summarizes the exposed building stock located in Tully Valley. There are 977 buildings located on areas of steep slopes countywide. The Town of Spafford has the greatest number of buildings and greatest percentage of buildings located on areas of steep slopes (216 – 9.6 percent). The Town of LaFayette has over five times as many buildings located in Tully Valley than the Town of Tully: 376 buildings and 71 buildings, respectively.
